PROCESSO N. 19489/2001

# Report - Into the P-36 Accident of 15 March 2001

Report For: Petroleo Brasileiro, SA (Petrobras)

Report By: Gary Kenney, B.Sc., M.Sc., Ph.D.

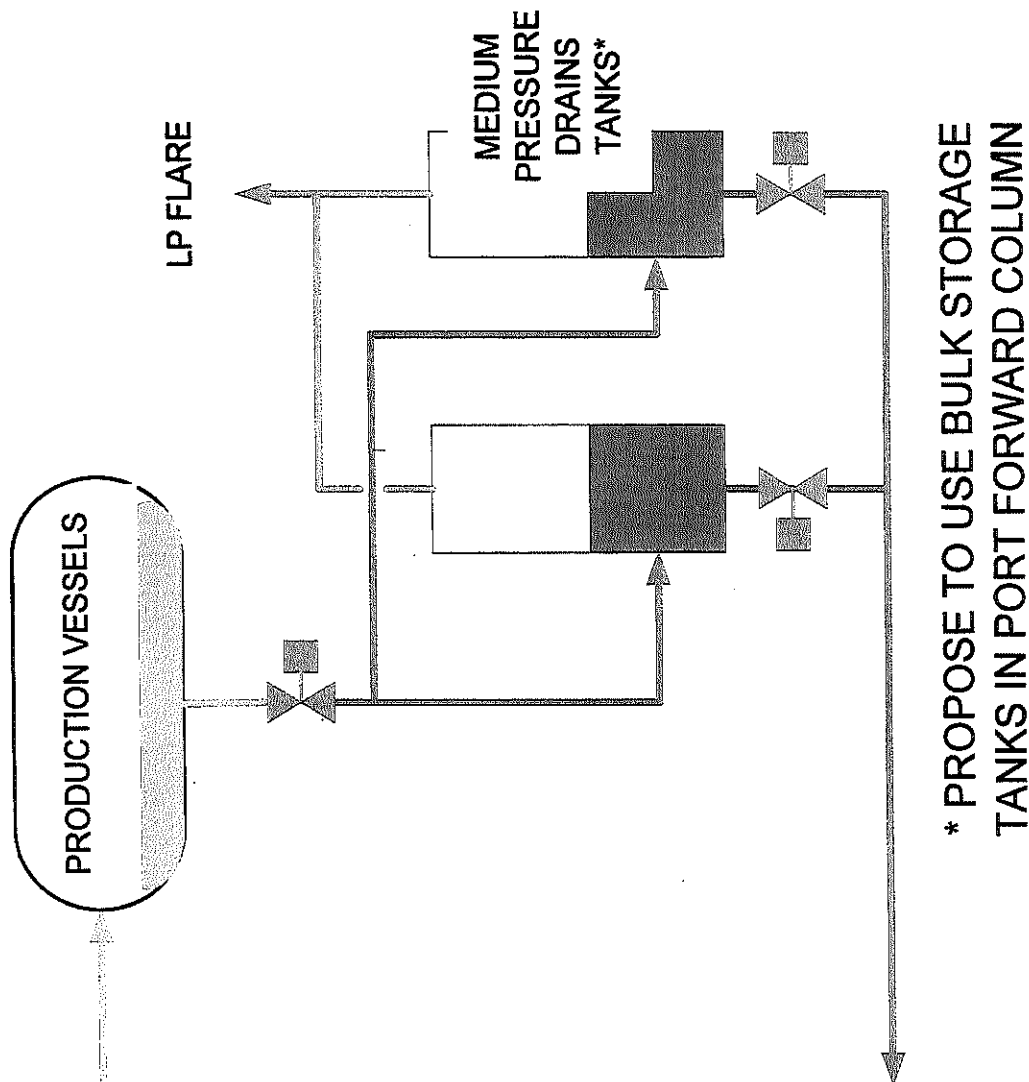
**FIGURE 1 – Initial Scheme for DST System was to use Bulk Storage Tanks in Port Forward Column**

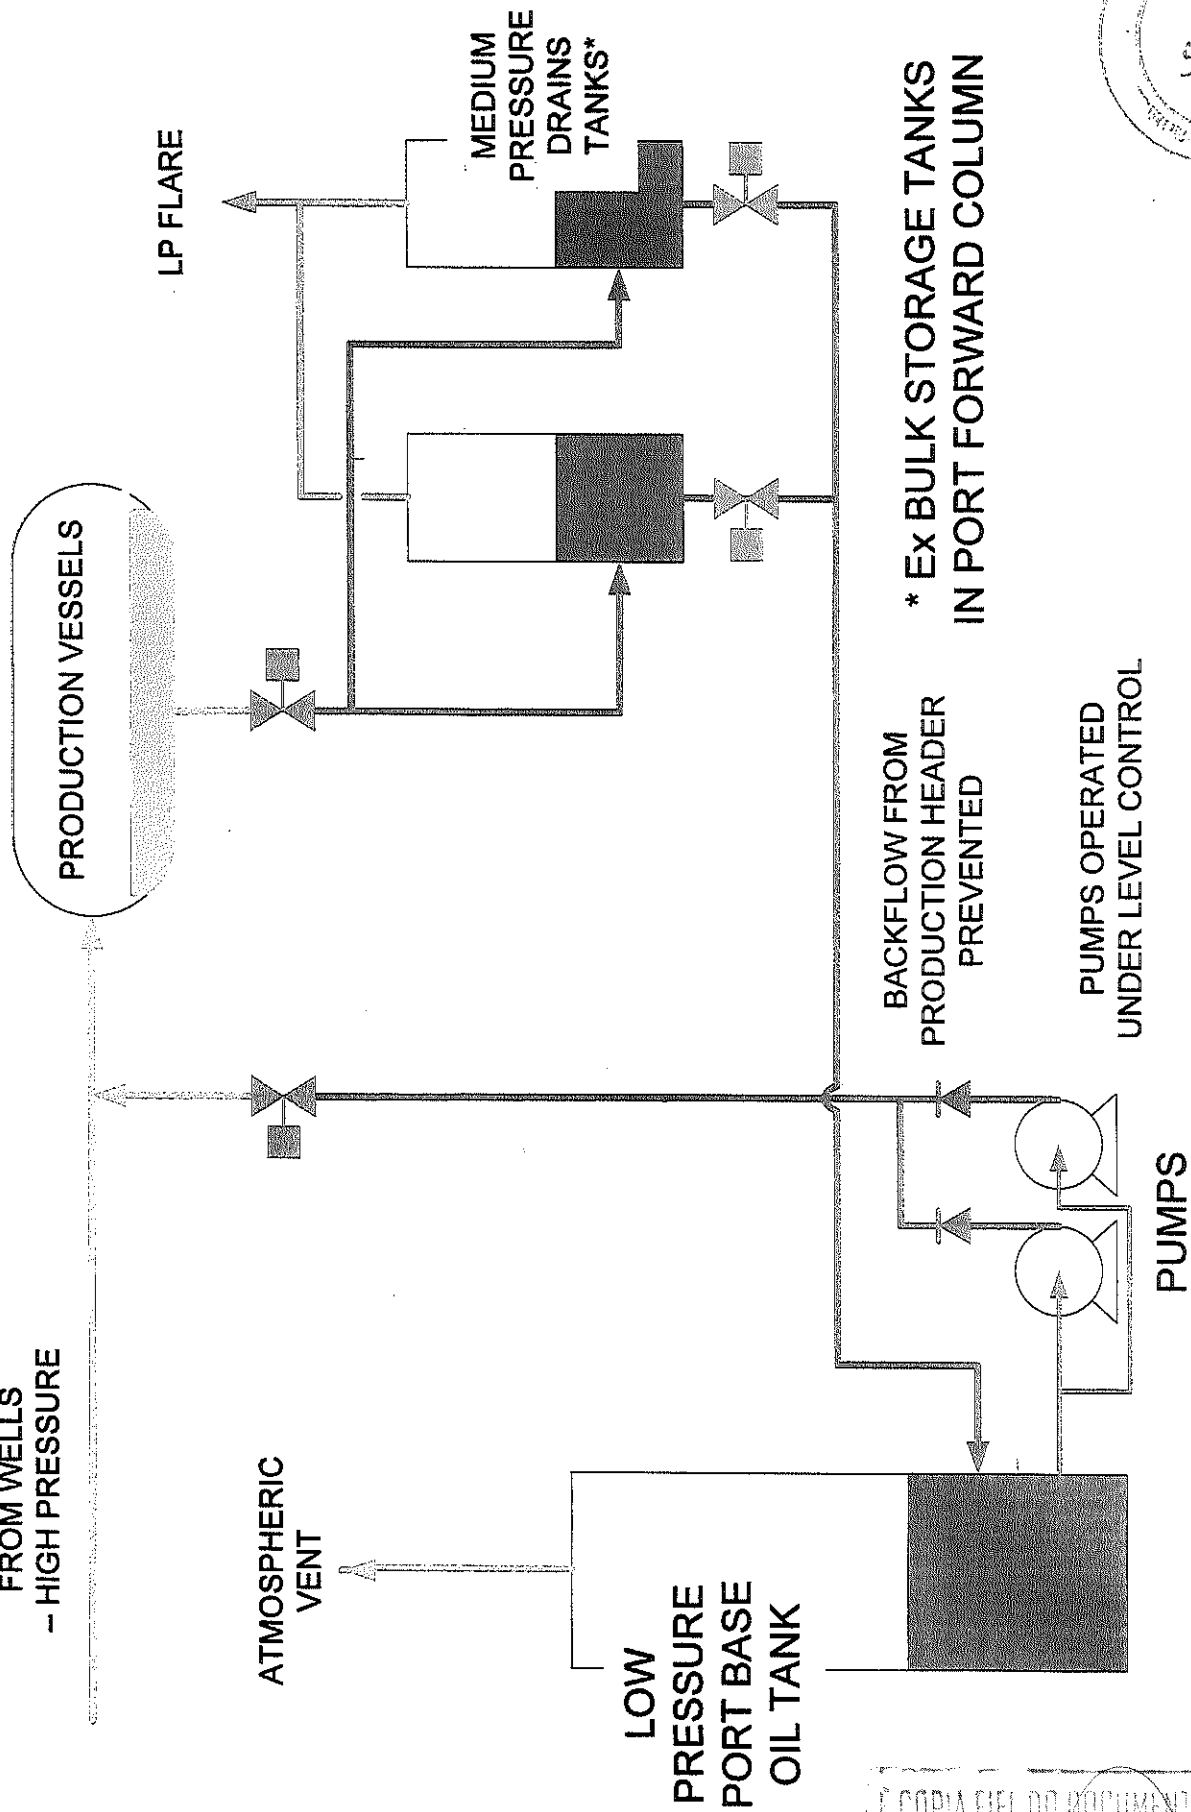
**FIGURE 2 – Initial Scheme for DST System with only one Base Oil Tank**

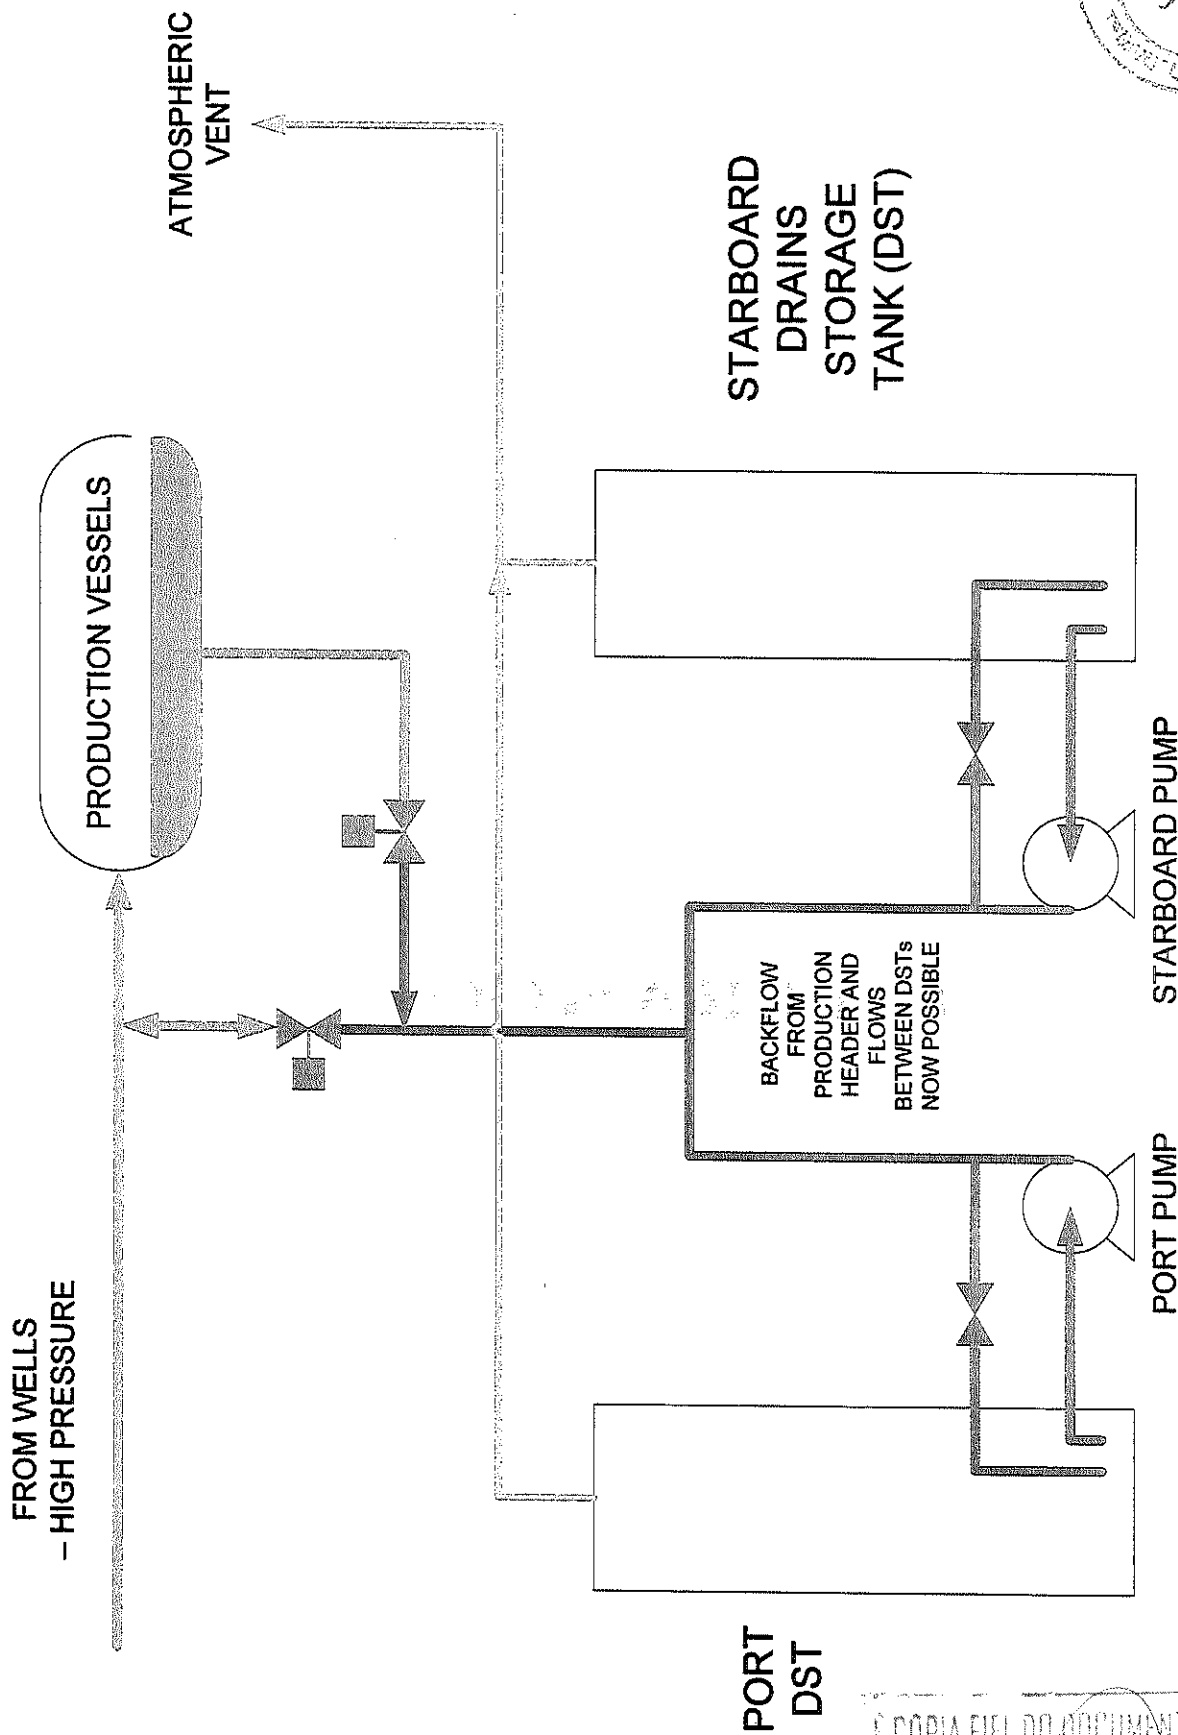
**FIGURE 3 - Final Scheme for DST System with both Base Oil Tanks**

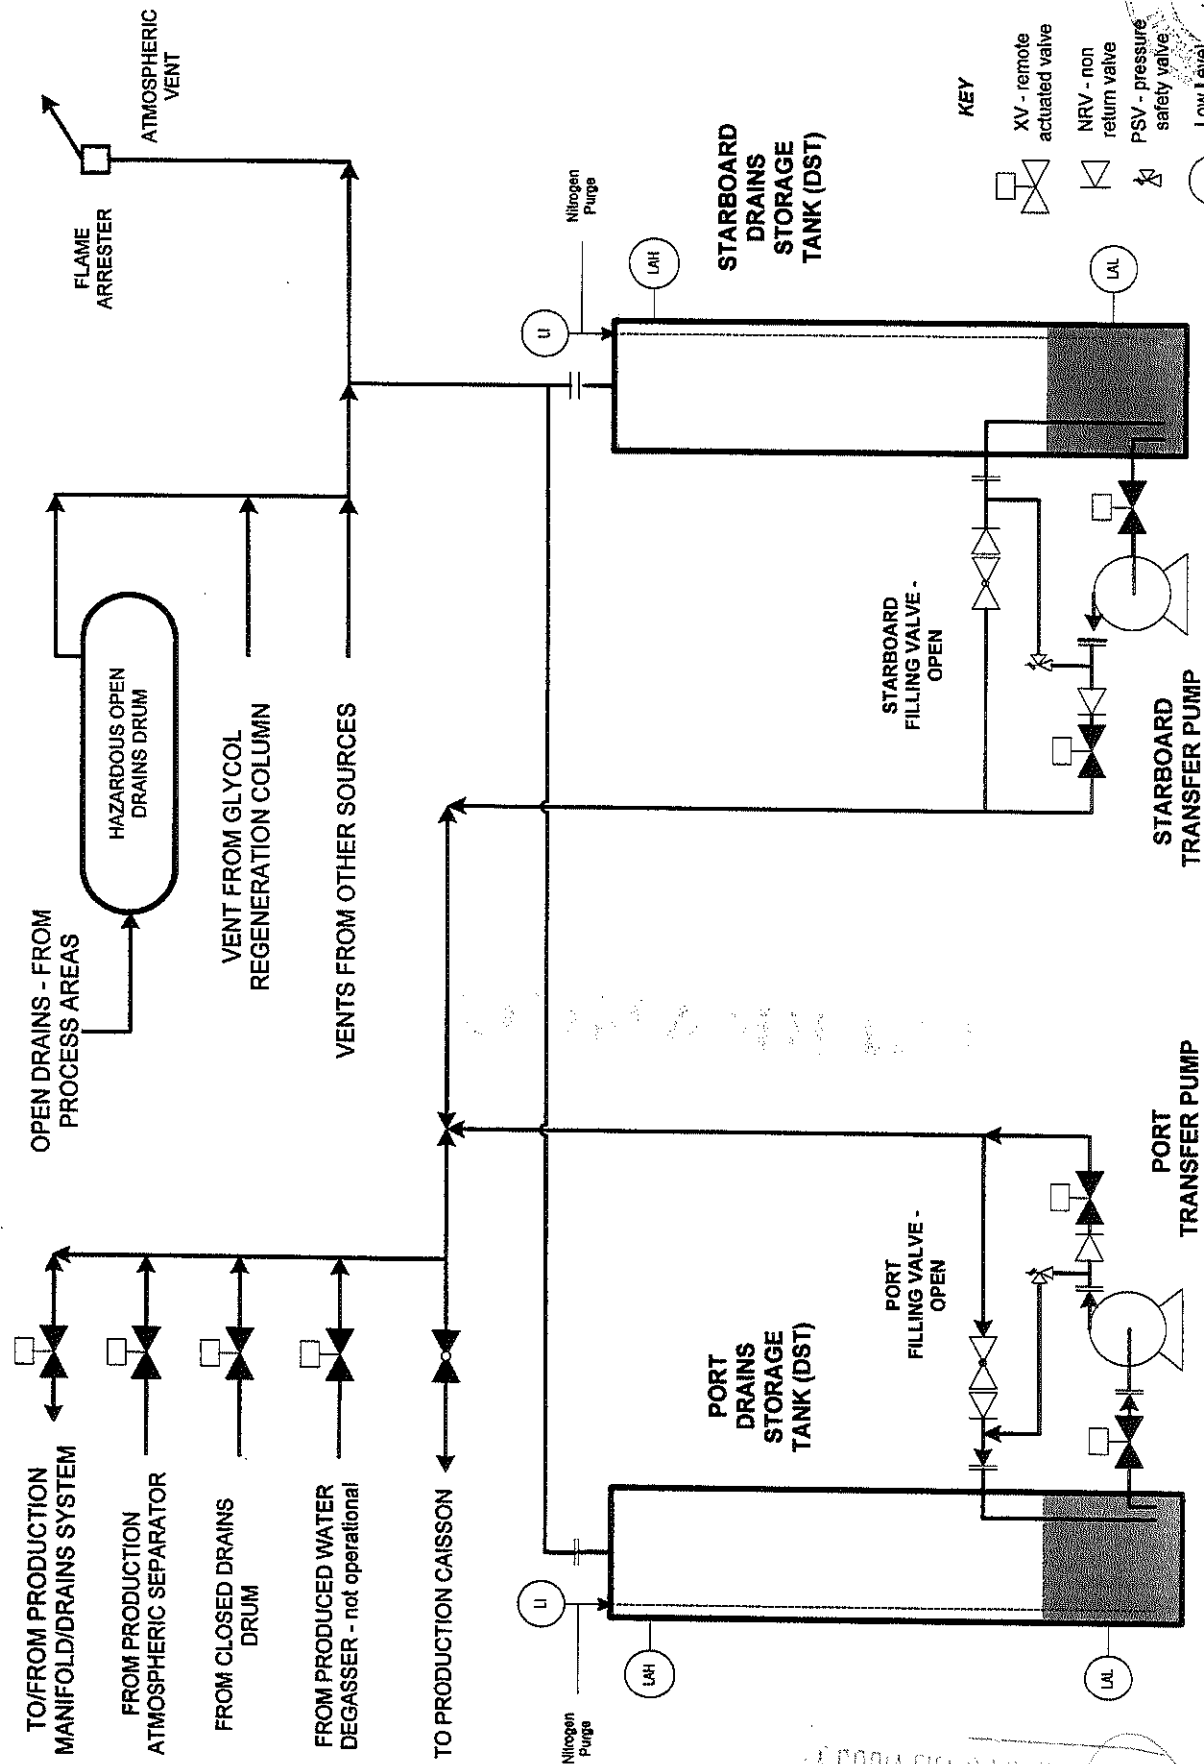
**FIGURE 4 – Final Scheme for DST System using Base Oil Tanks**

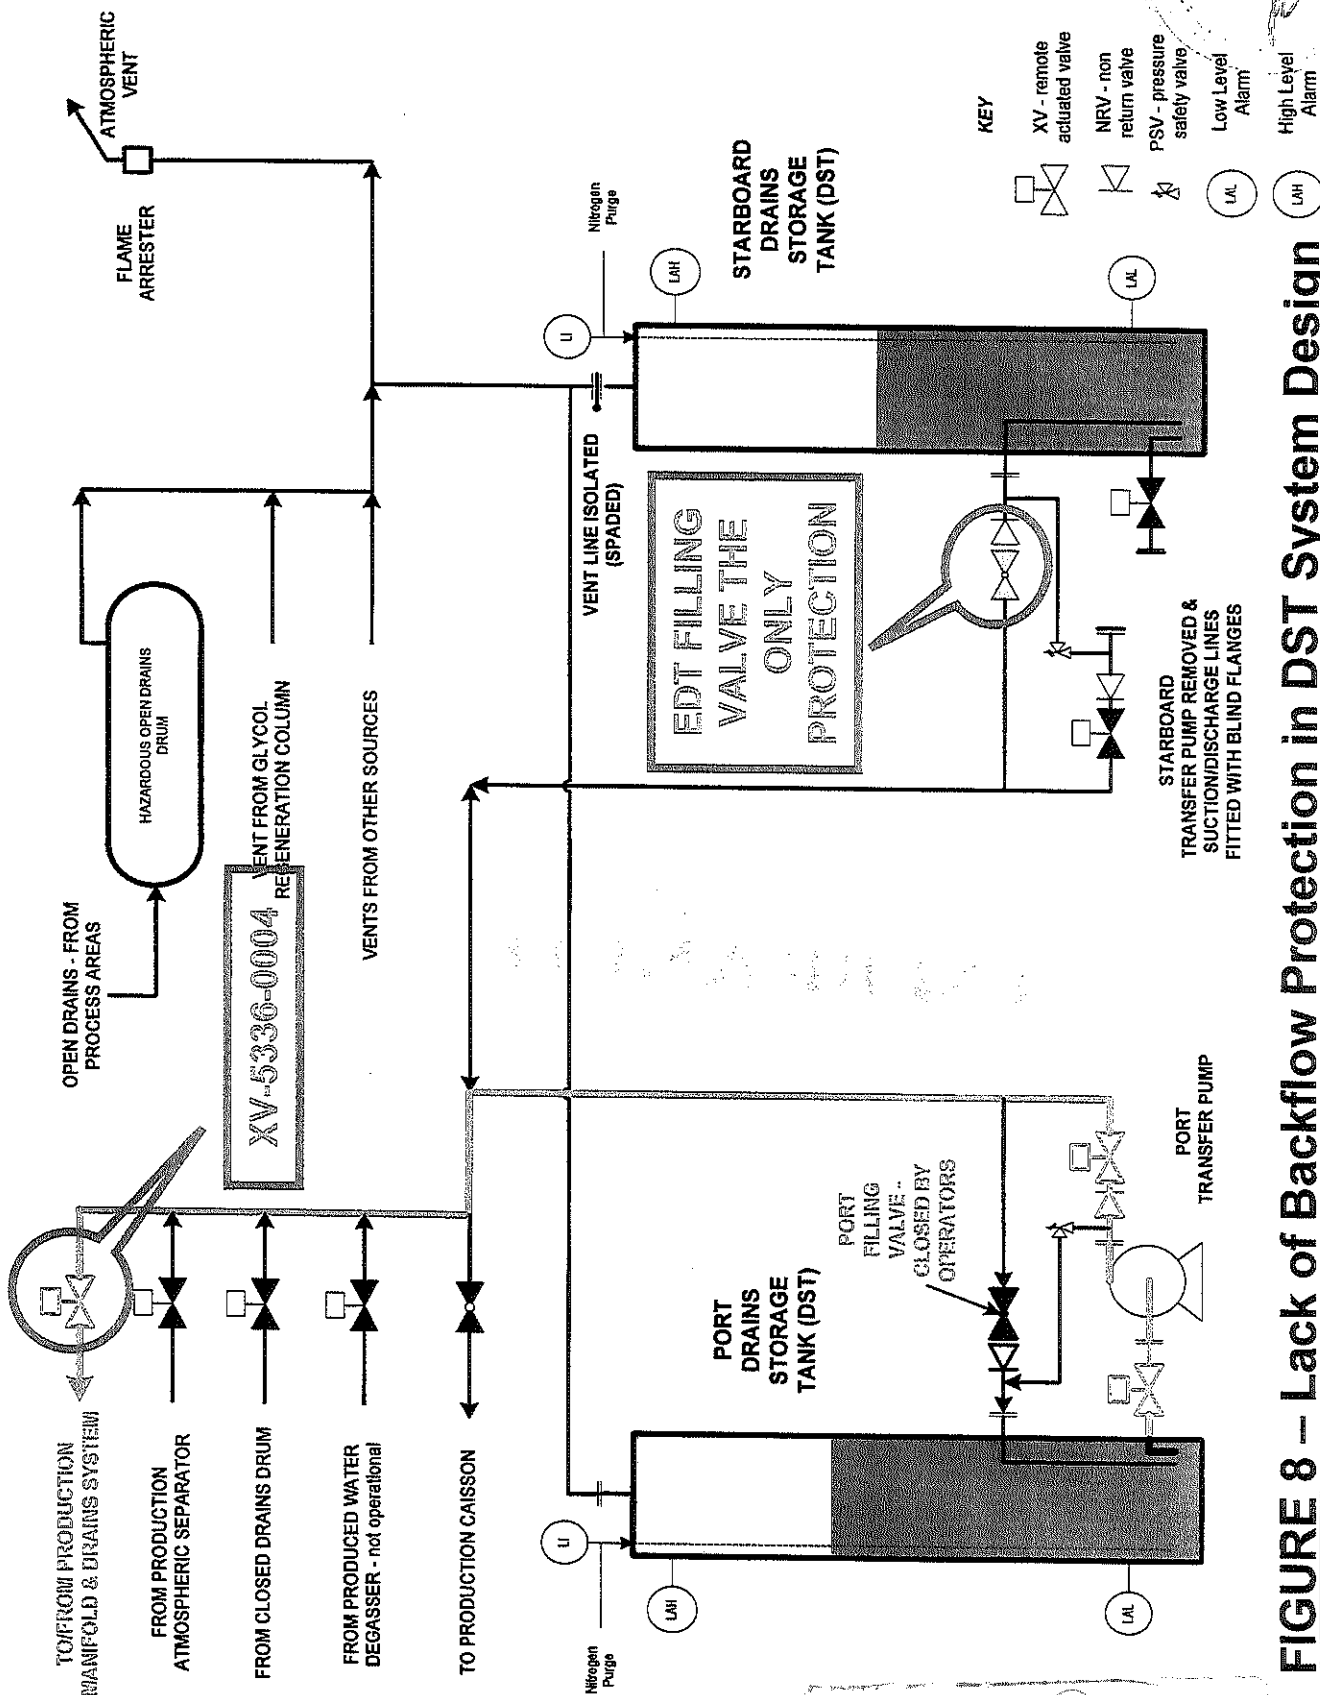
**FIGURE 8 – Lack of Backflow Protection in DST System Design**

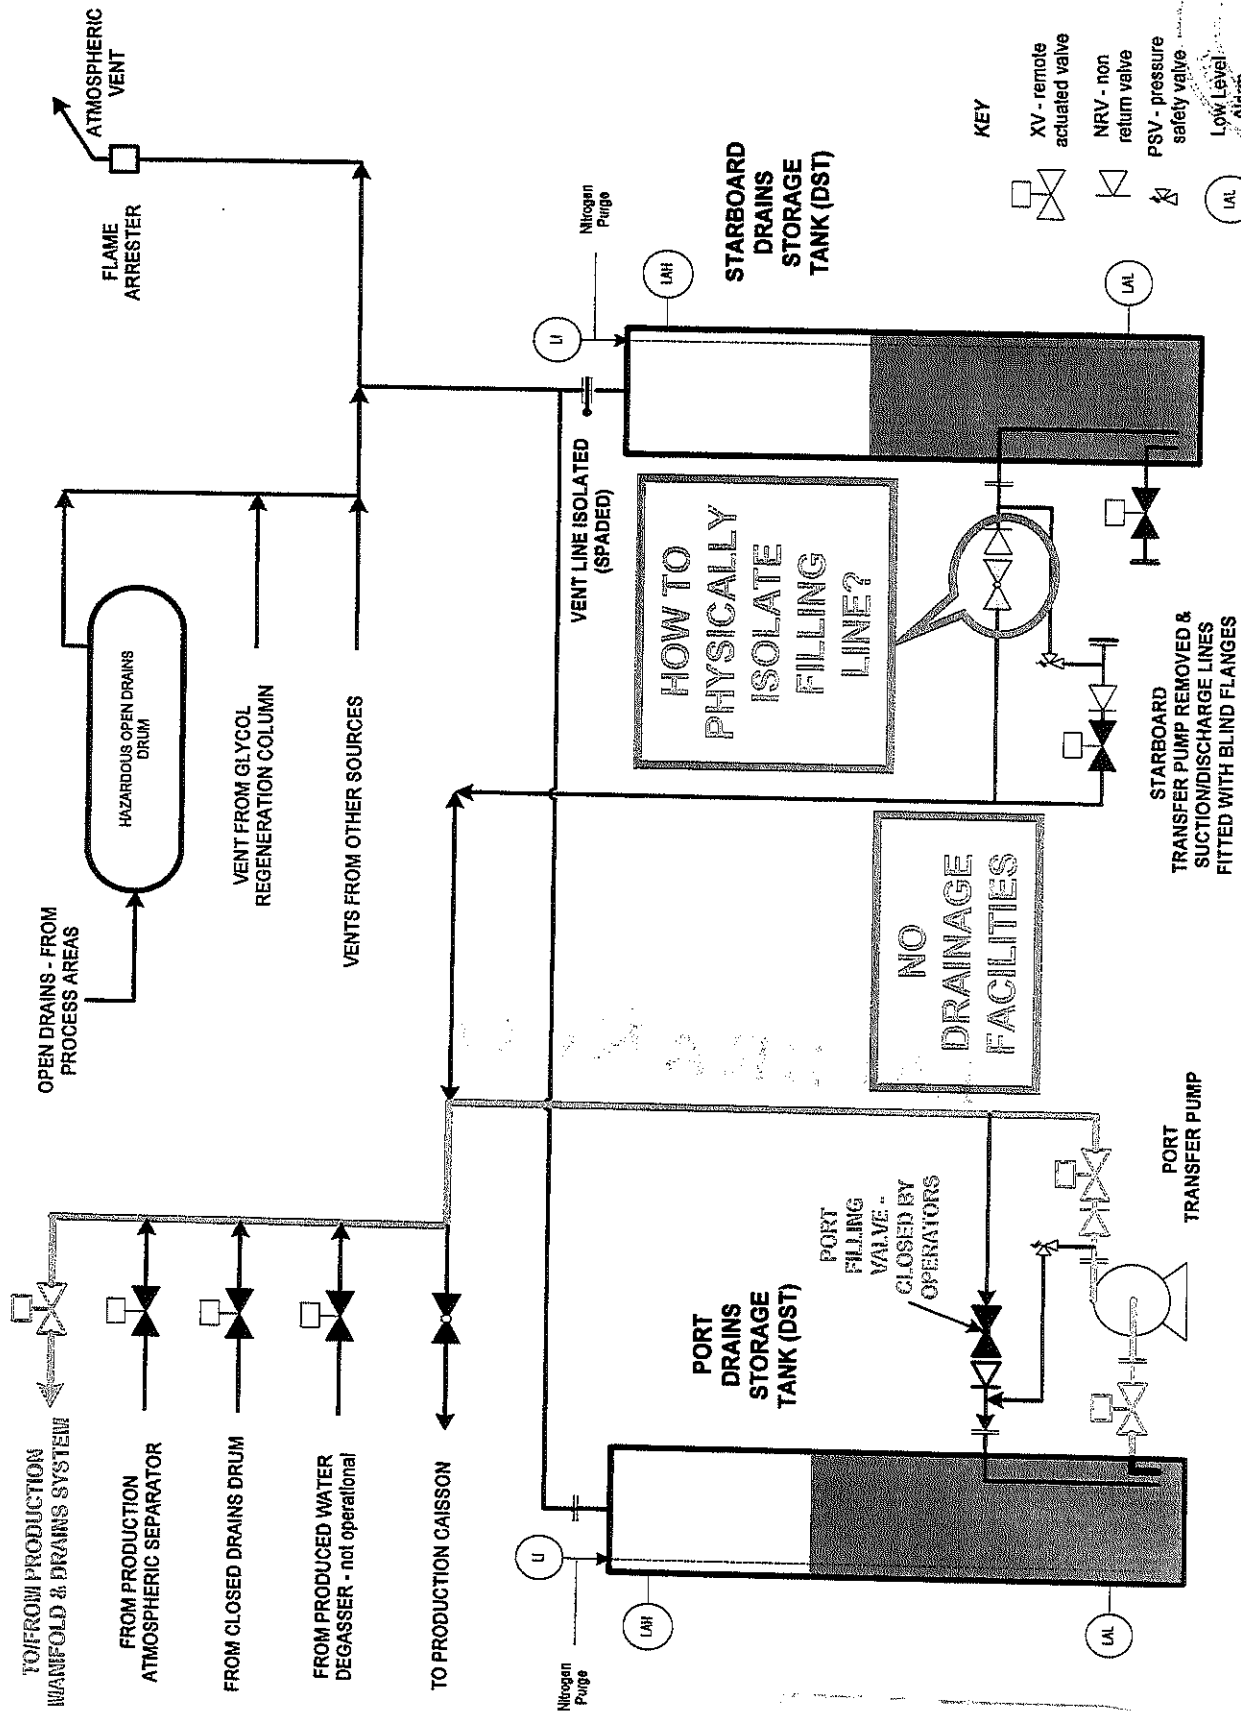
**FIGURE 10 – Lack of Isolation & Maintenance in DST System Design**

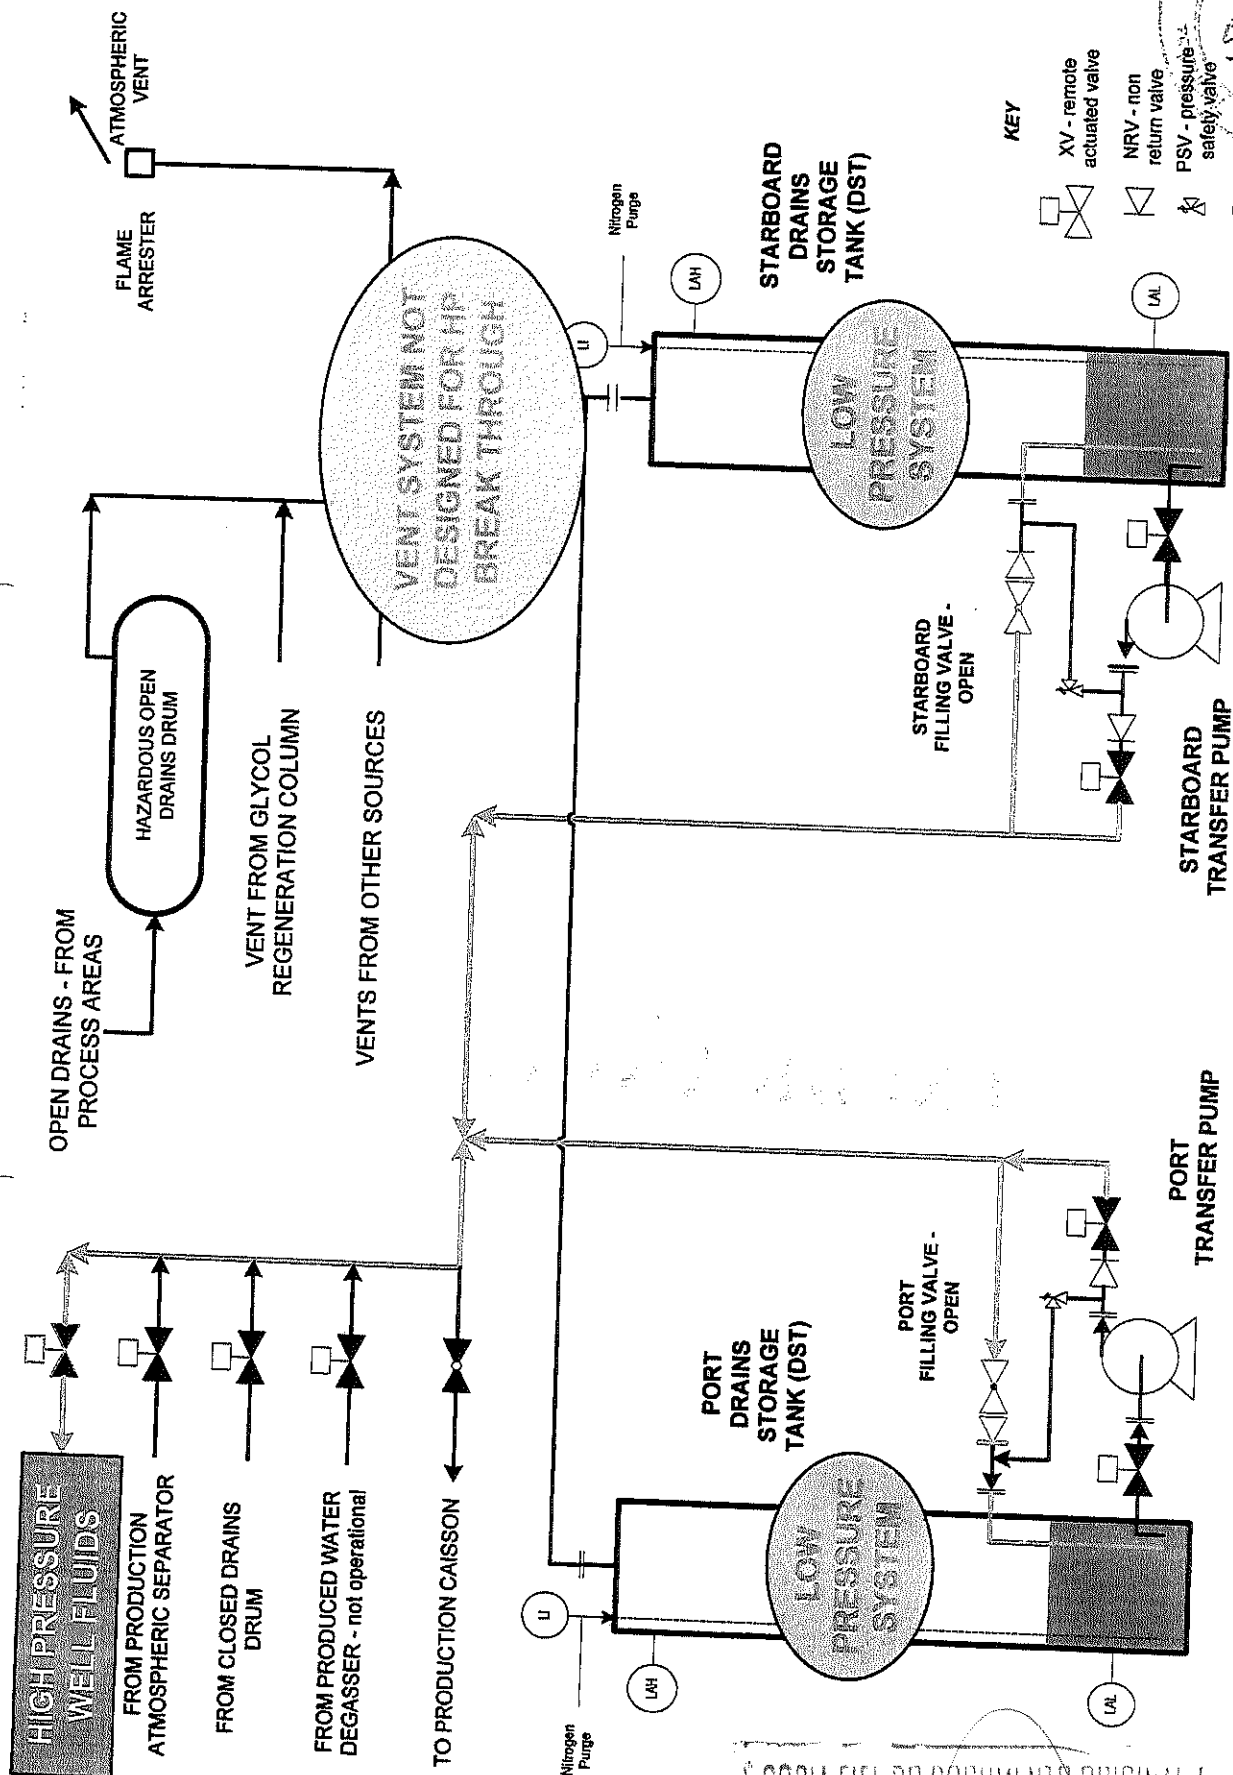
**FIGURE 11 – ‘An Accident waiting to Happen’**

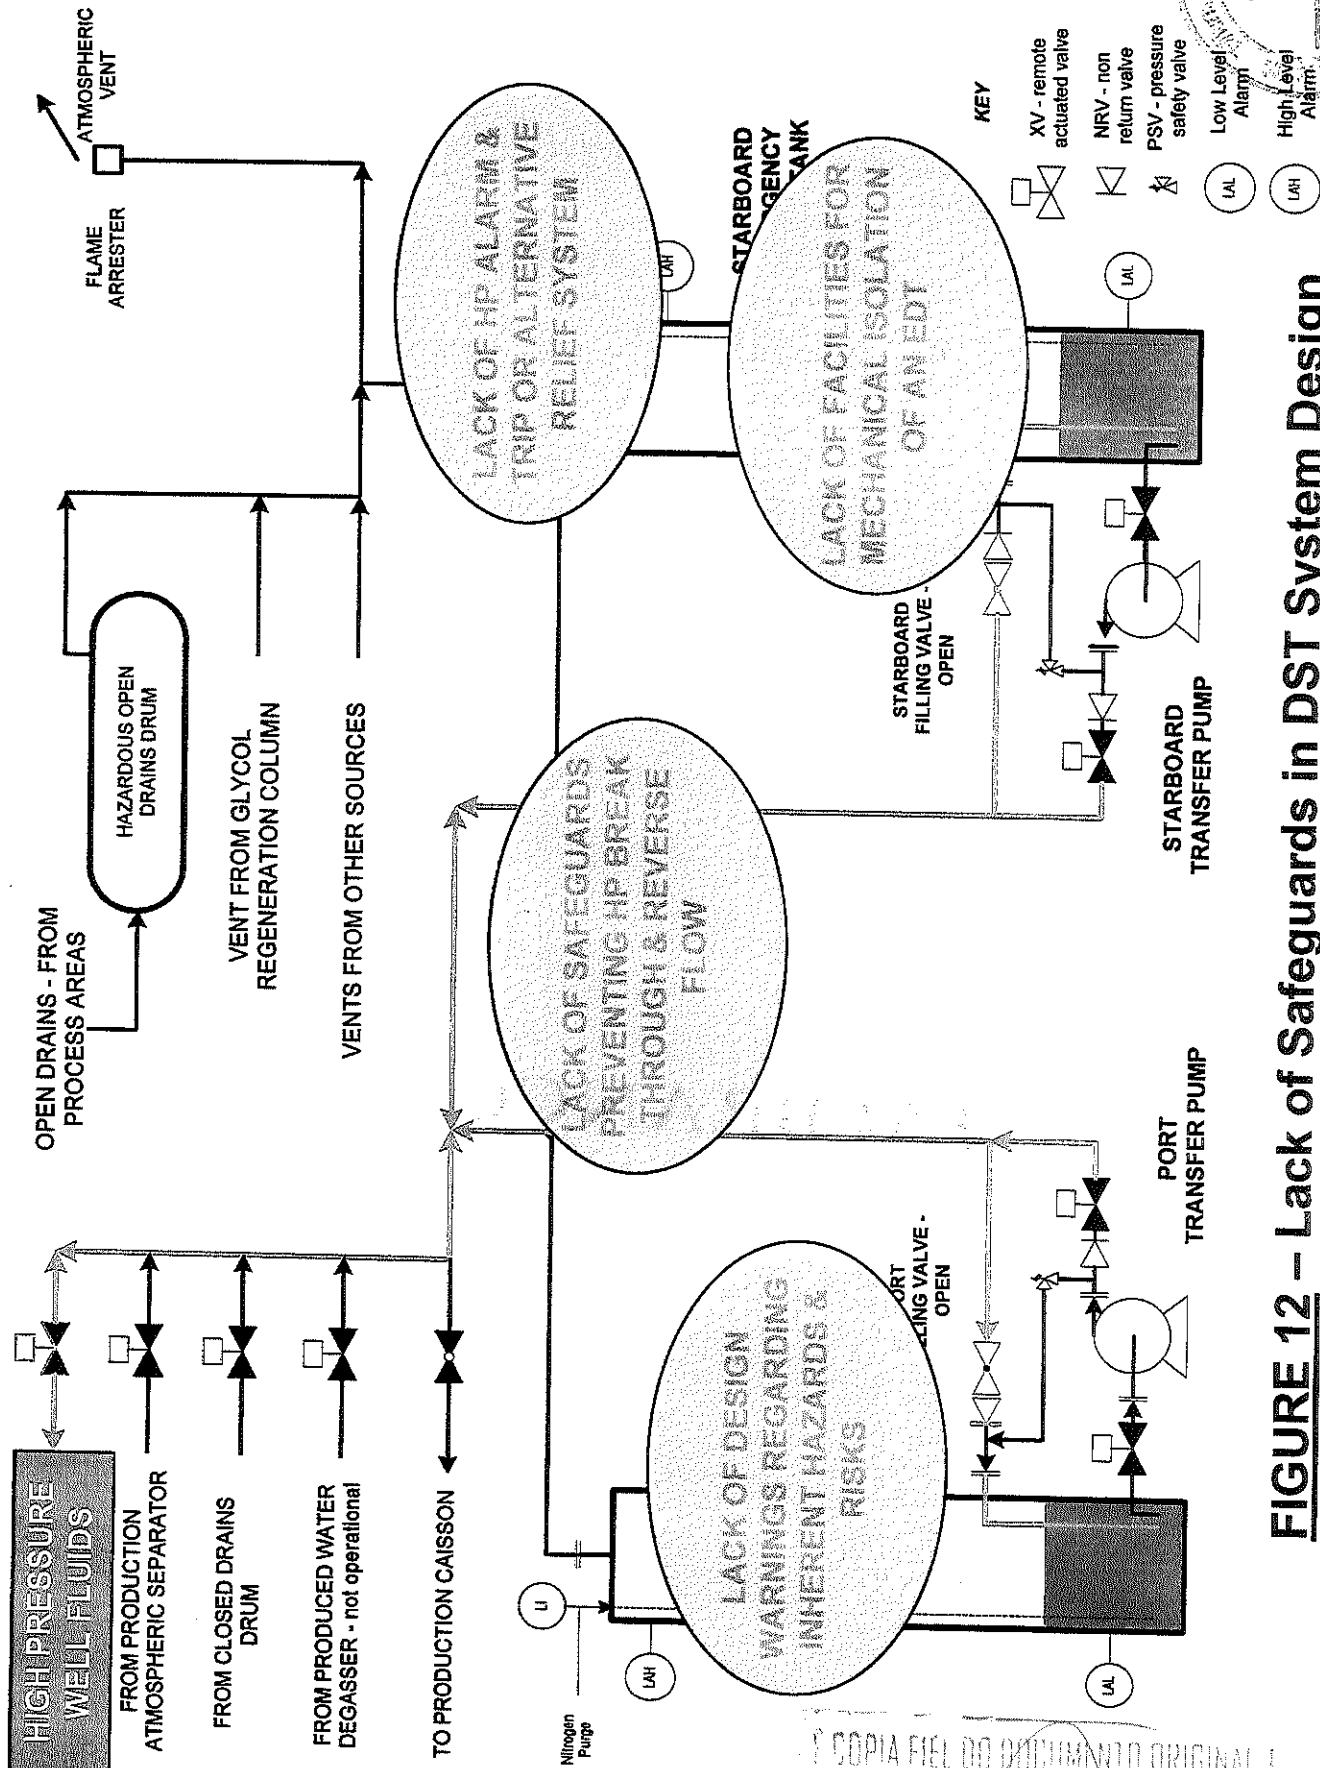
**FIGURE 12 – Lack of Safeguards in DST System Design**

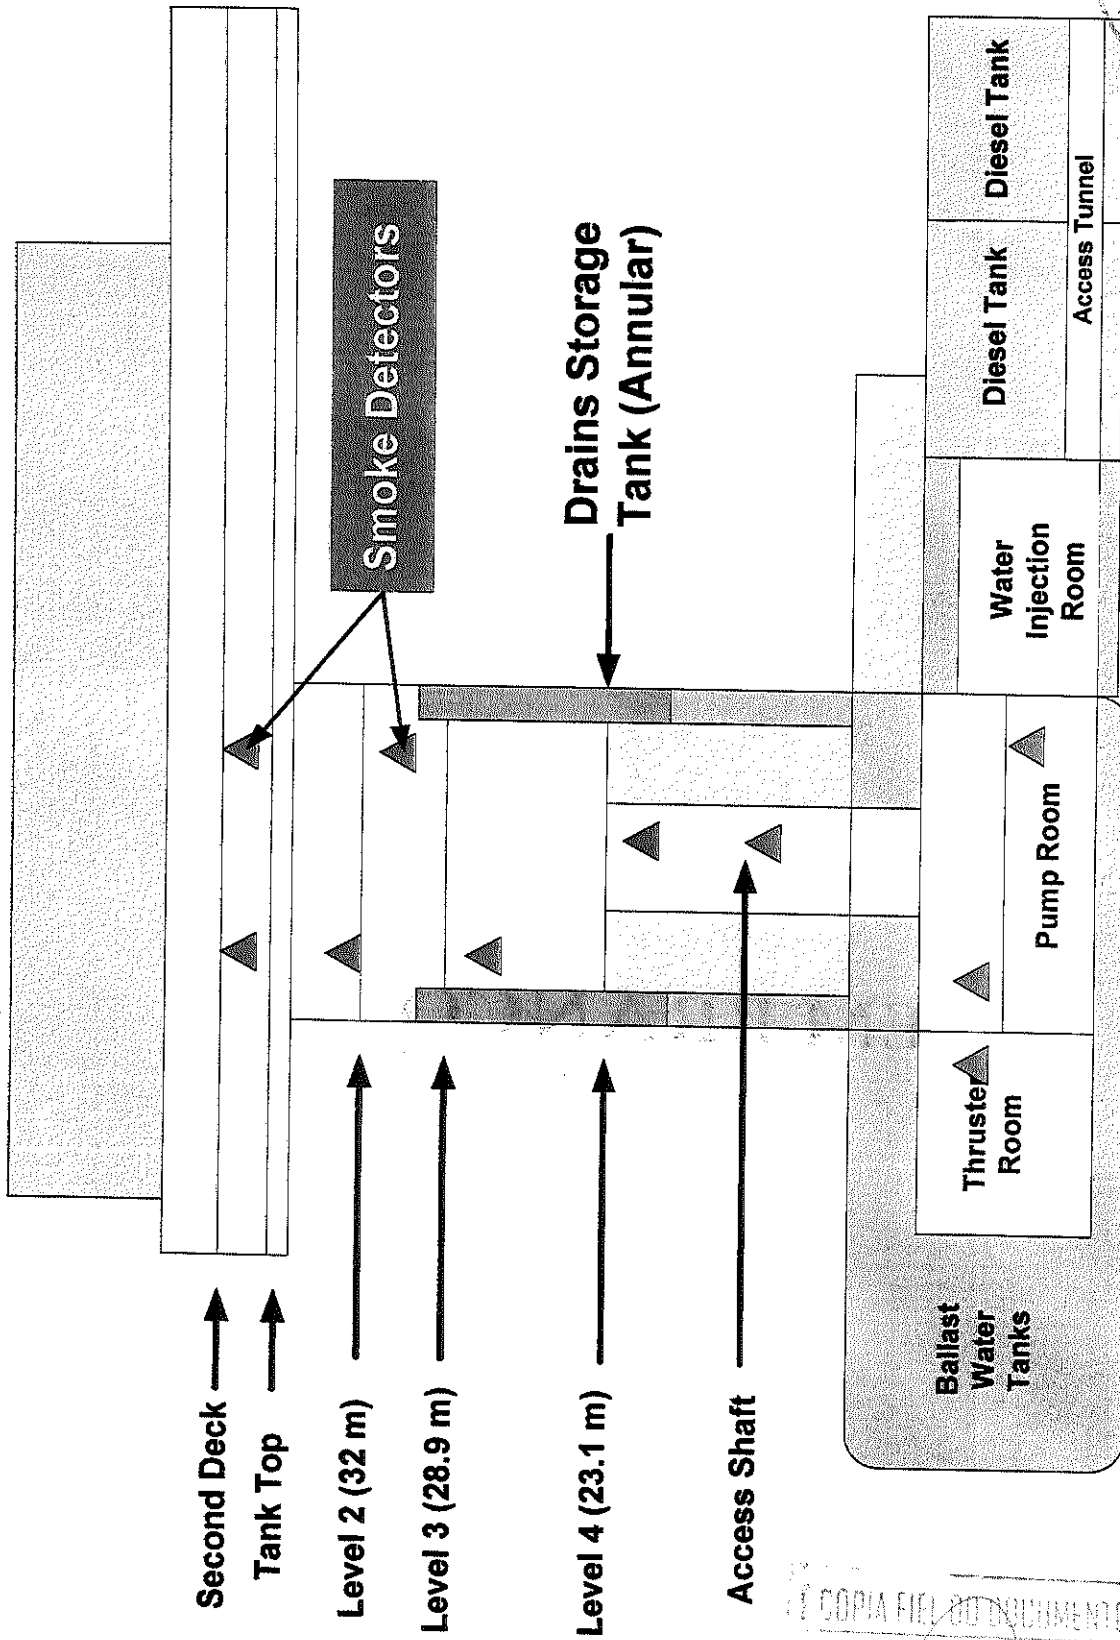
**FIGURE 14 – Smoke Detectors in Aft Columns**

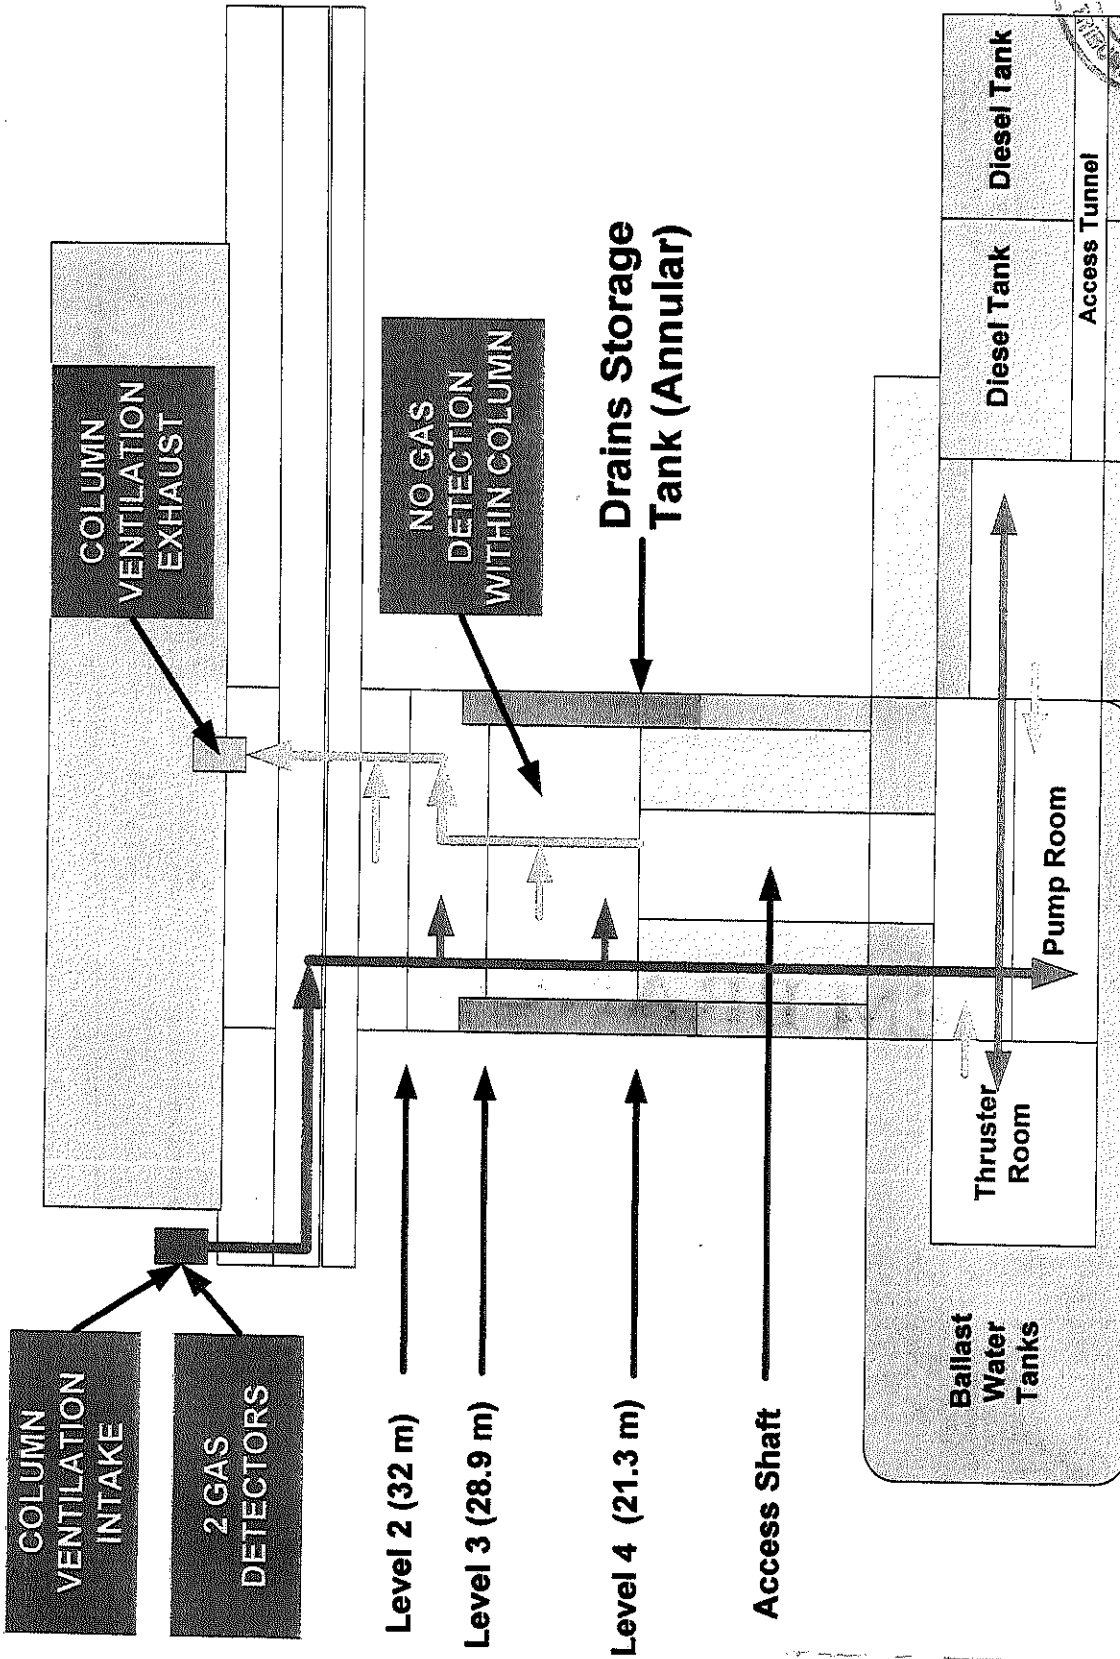
**FIGURE 15 – No Gas Detection inside Aft Columns**

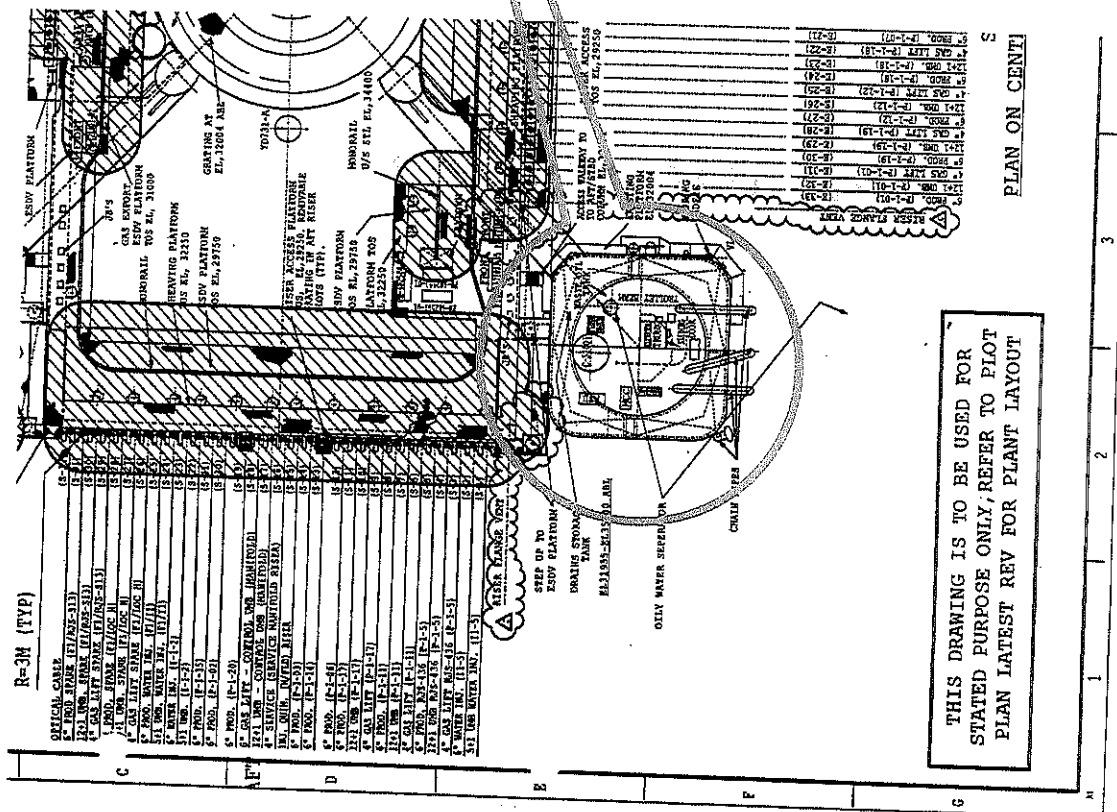
FIGURE 18 - Hazardous Area Classification Schedule for DSTs

Drawings  
showed no  
Hazardous Areas  
in Columns – not  
even 3m radius.

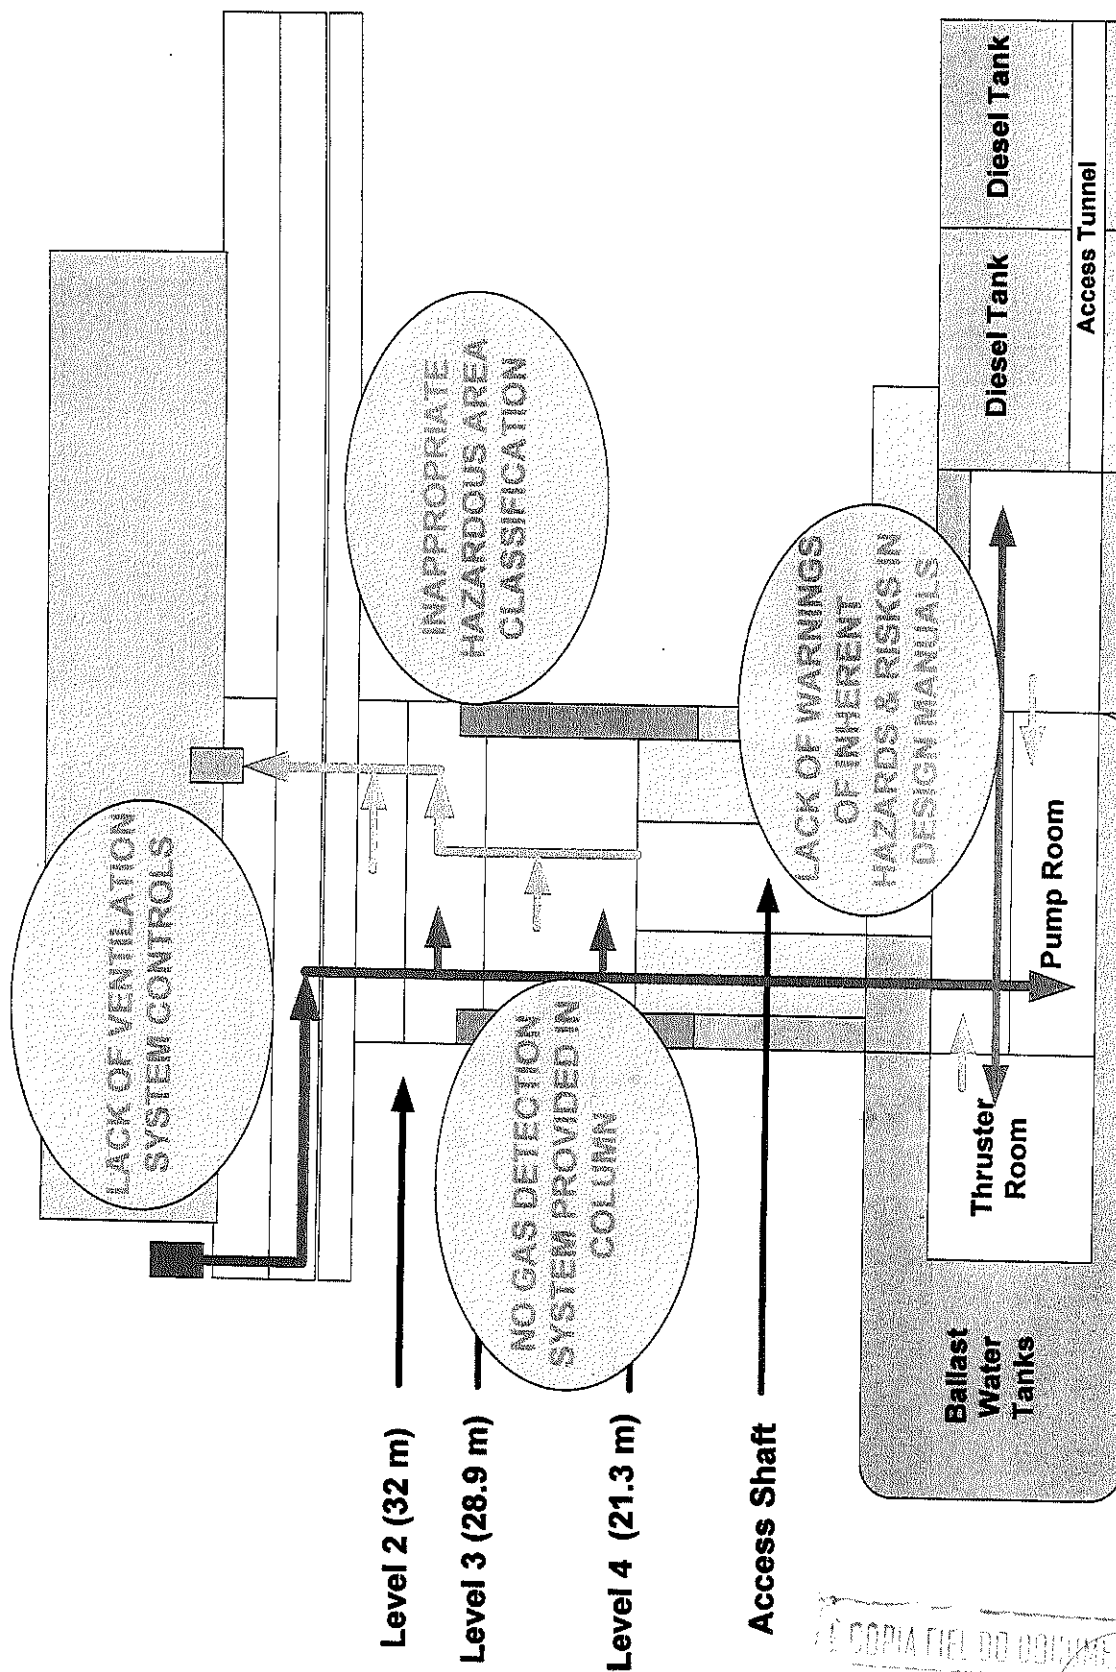
**FIGURE 21 – Lack of Safeguards in Aft Column Design**
