PROCESSO N. 19489/2001

# Report - Into the P-36 Accident of 15 March 2001

Report For: Petroleo Brasileiro, SA (Petrobras)

Report By: Gary Kenney, B.Sc., M.Sc., Ph.D.

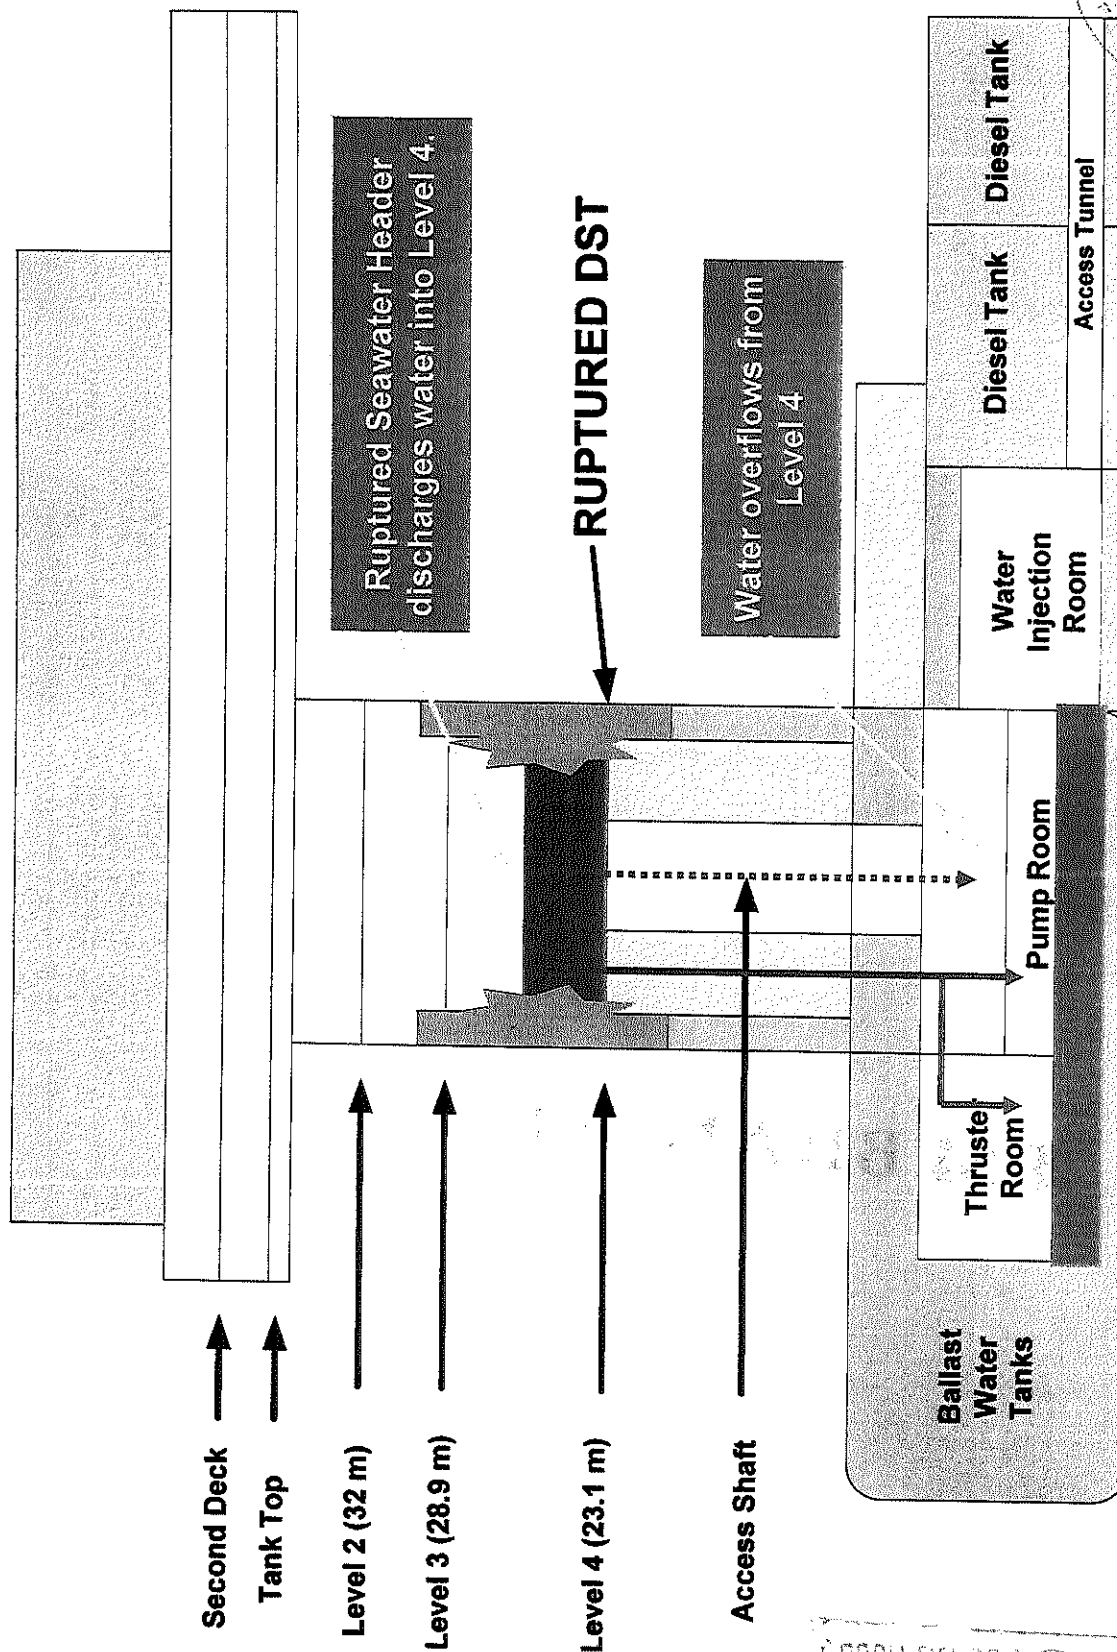
**FIGURE 22 – First Event causes 2 degree Inclination**

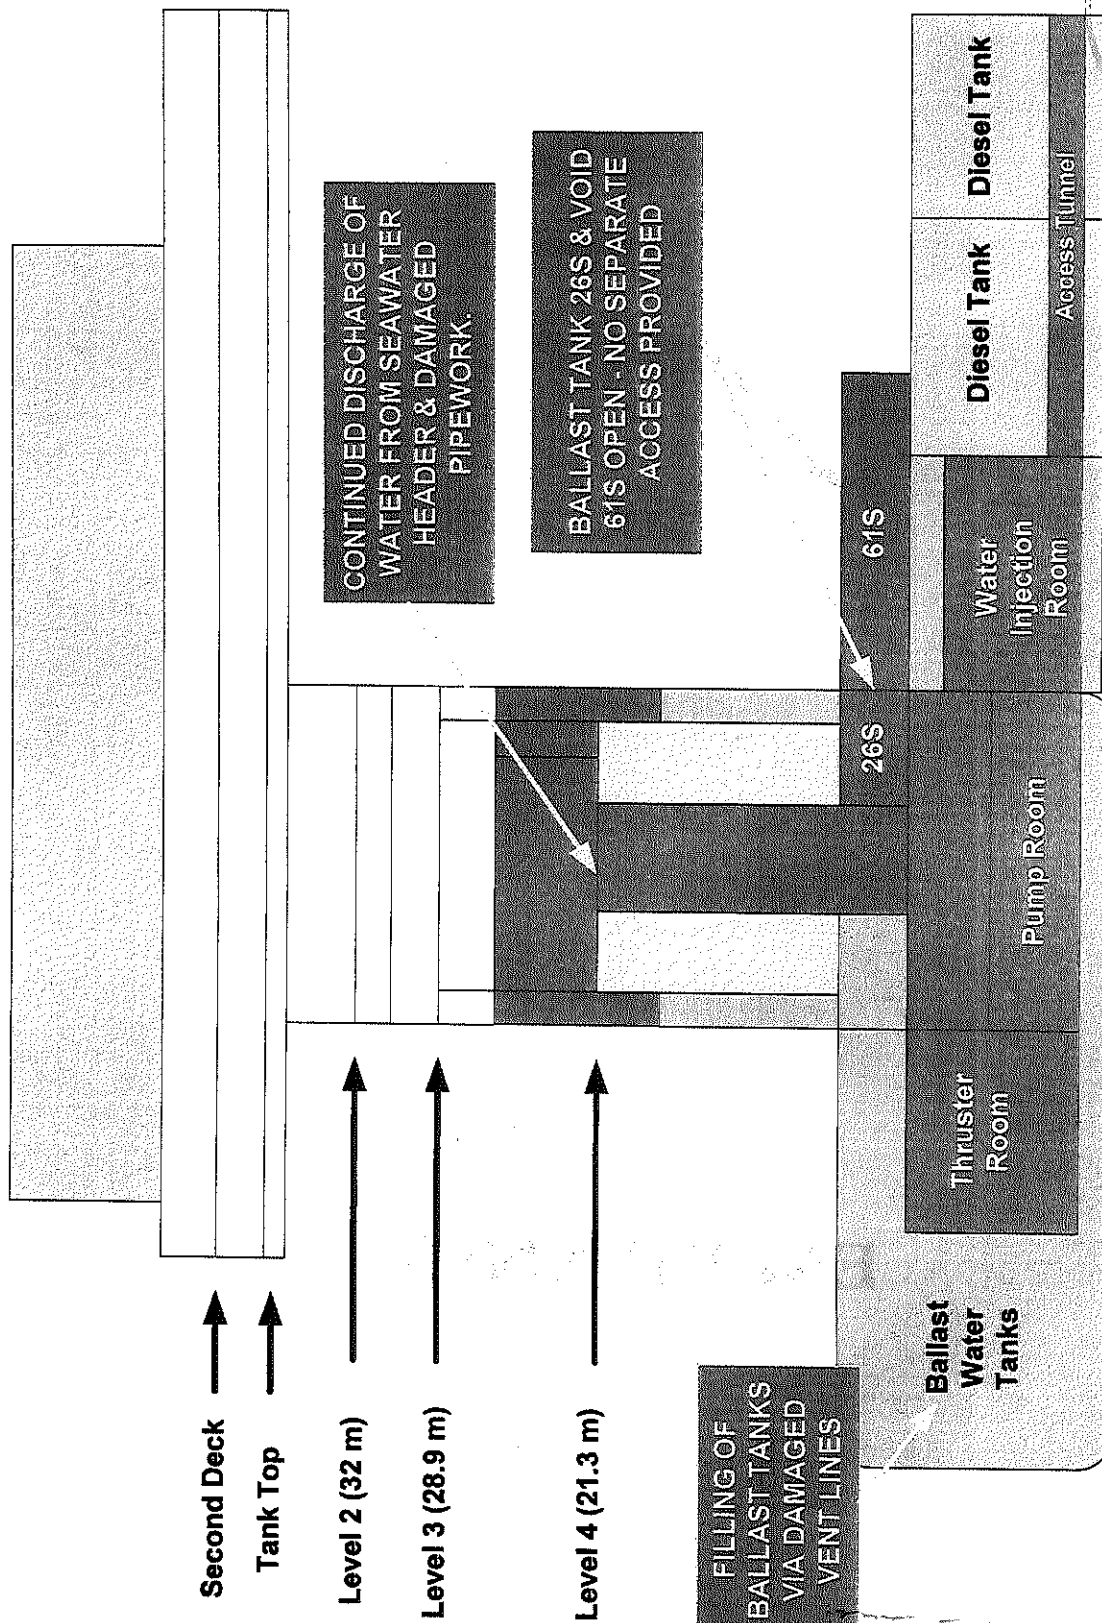
**FIGURE 23 – Internal Flooding following Second Explosion**

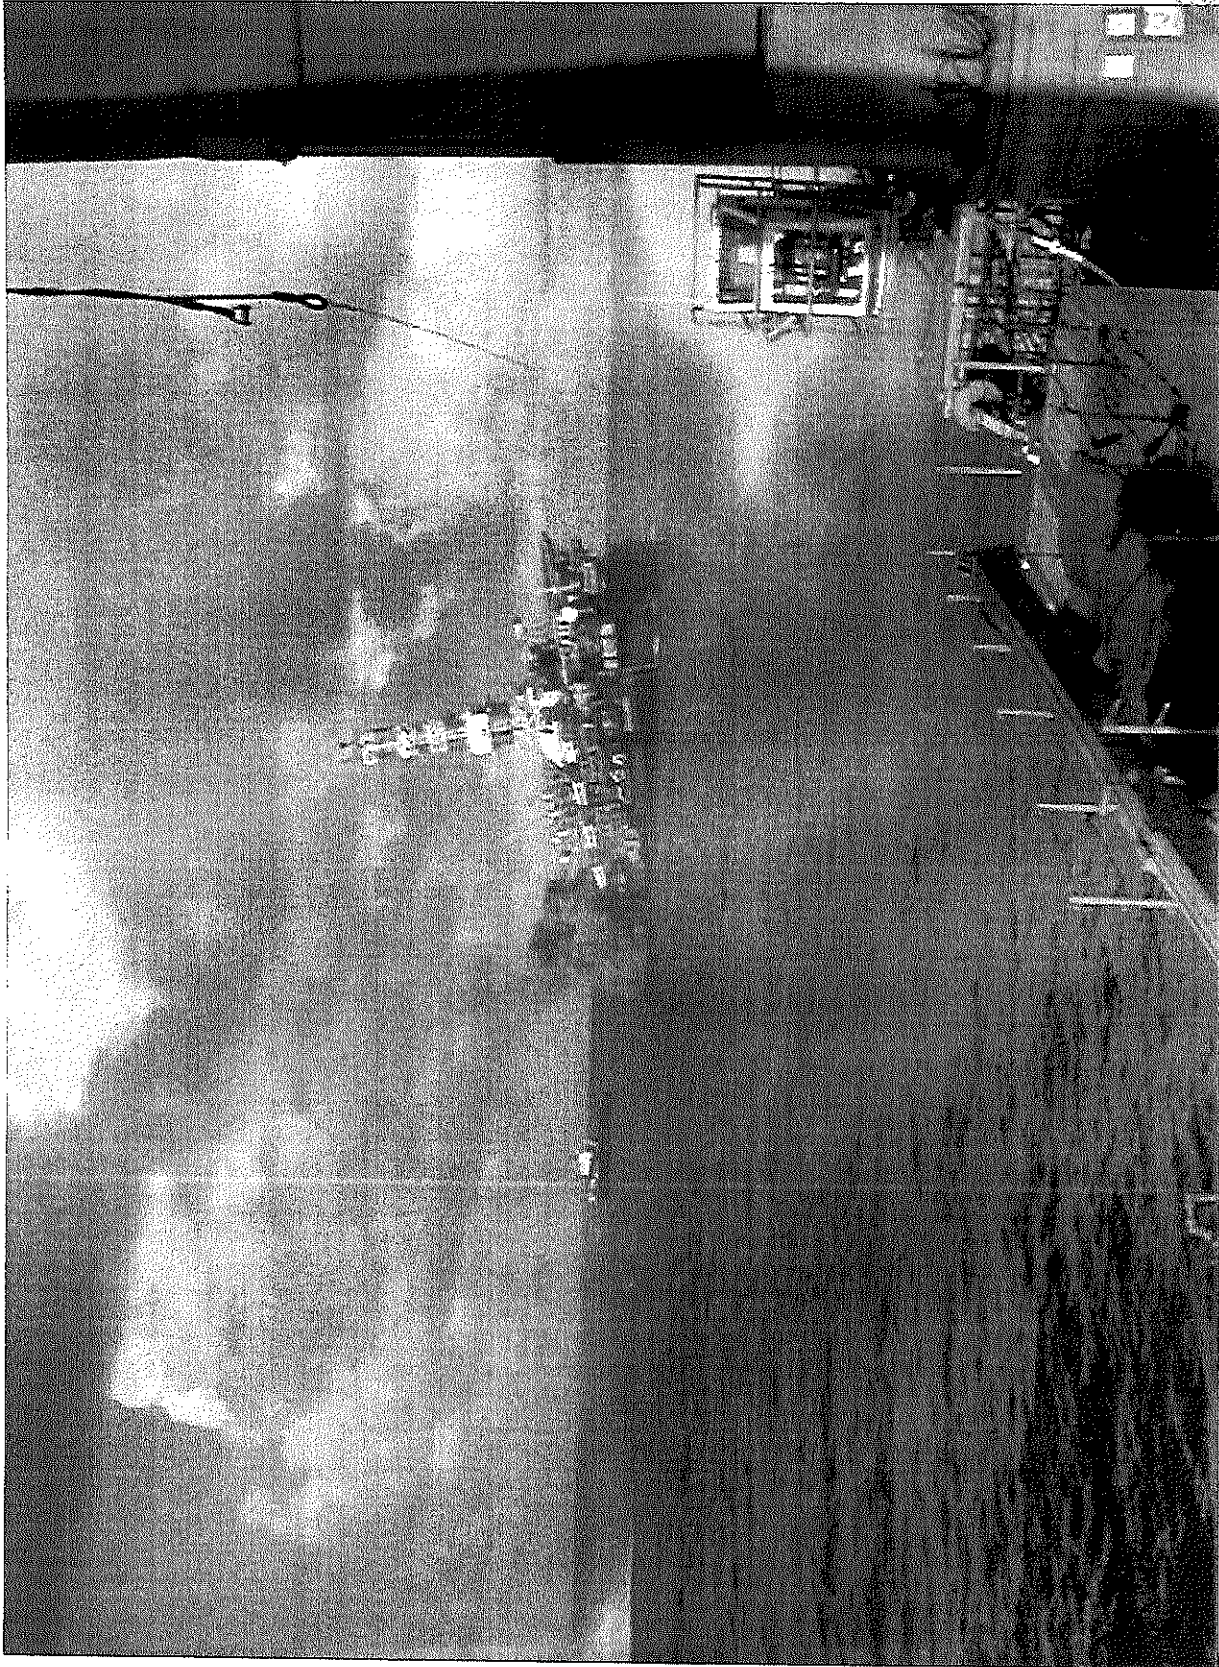
**FIGURE 24** – Sudden Loss of Stability at about 08-10

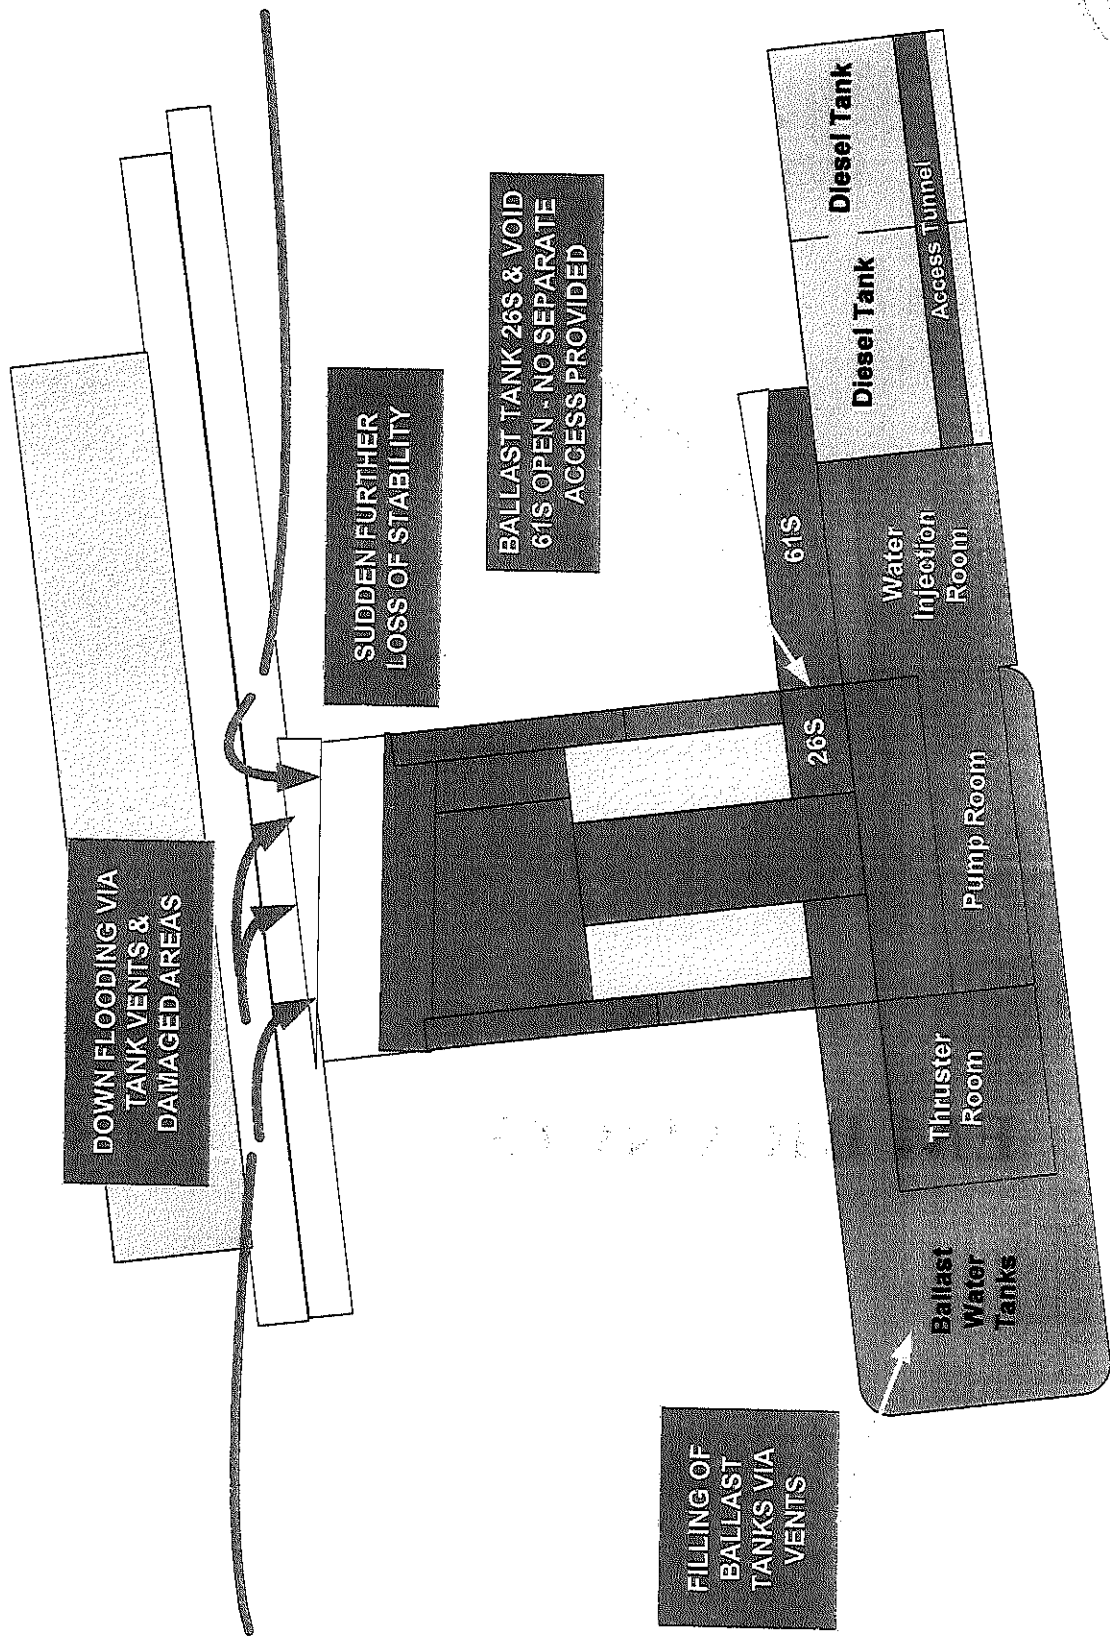
**FIGURE 25 – Down Flooding of Starboard Aft Column**

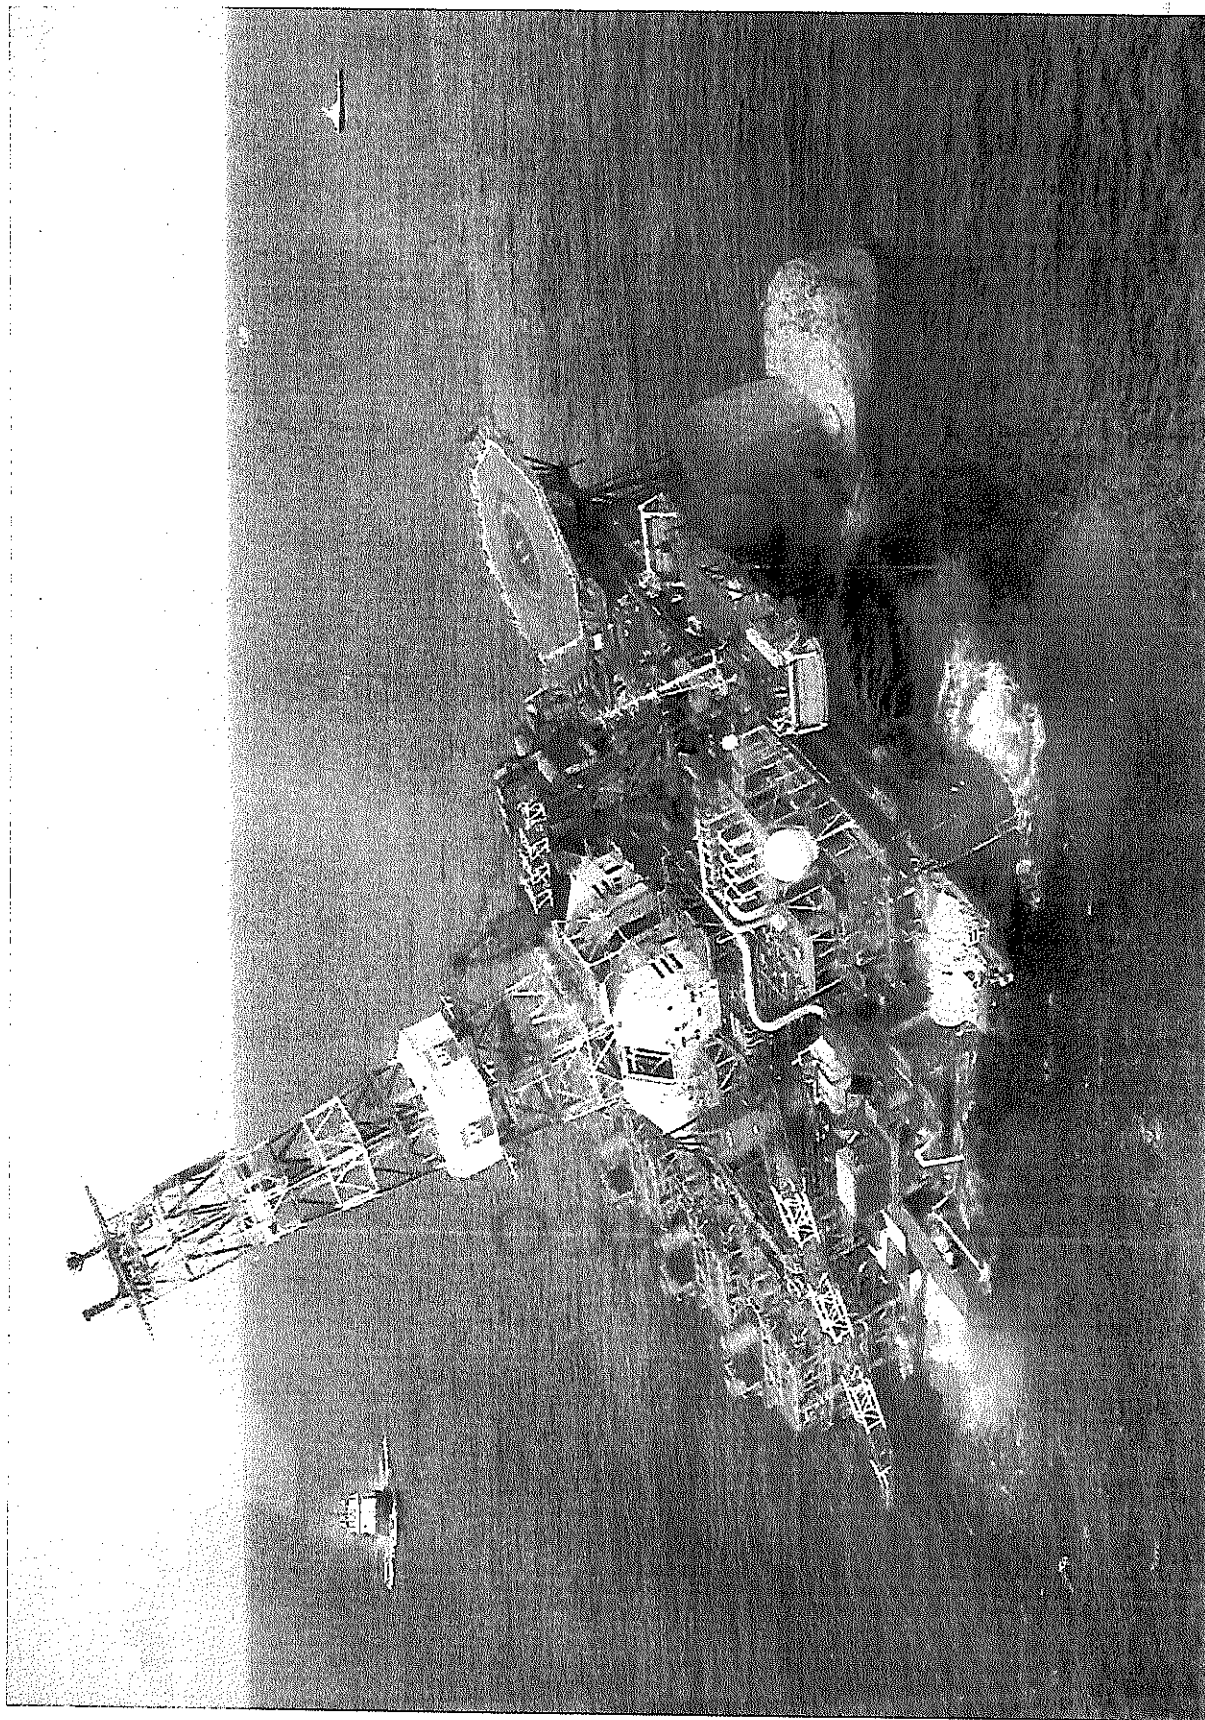
**FIGURE 26 – Progressive Flooding of Unit**

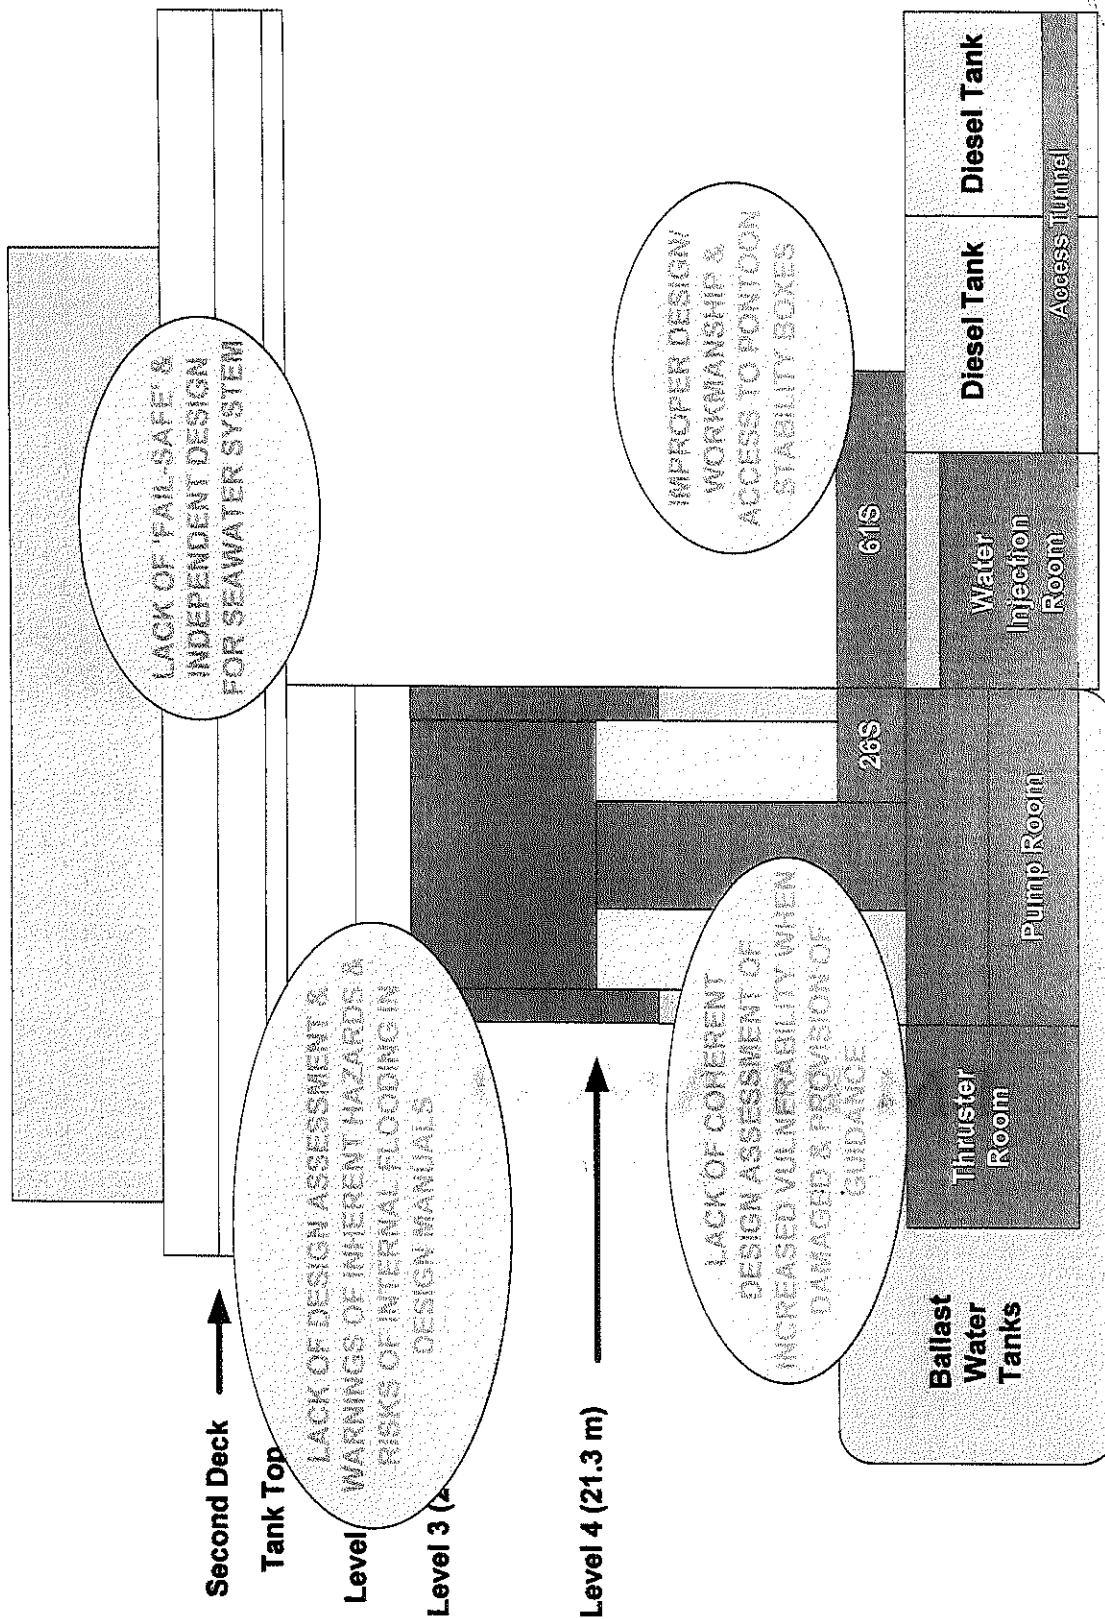
**FIGURE 27 – Design Flaws & Lack of Marine Safeguards**
