PROCESSO N. 19489/2001

# Report - Into the P-36 Accident of 15 March 2001

Report For: Petroleo Brasileiro, SA (Petrobras)

Report By: Gary Kenney, B.Sc., M.Sc., Ph.D.

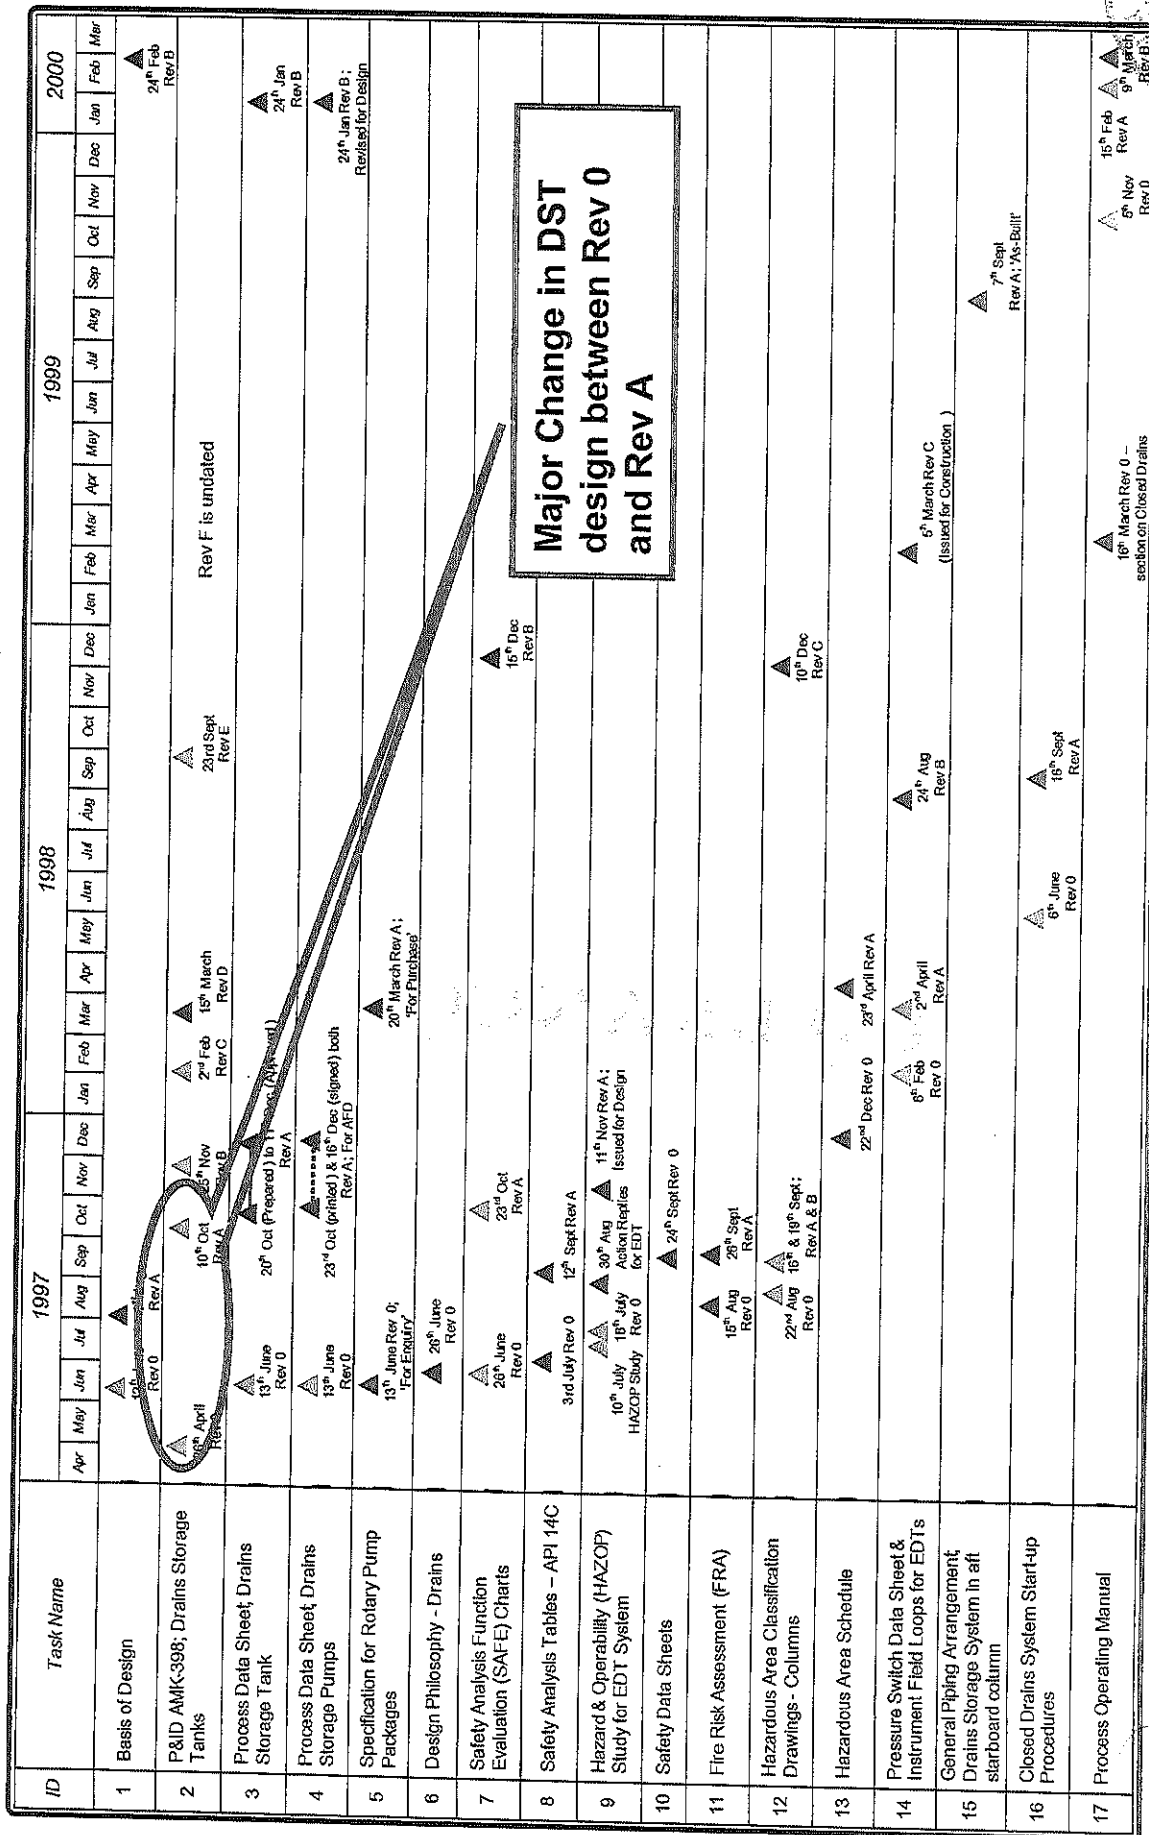
**FIGURE 5 – Timeline for DST System – Document Revisions**

- 2.1.8 Time-lines summarising the DST document revisions and the development of the DST system design are shown in Figures 5 & 6. Following completion of AMEC's design phase and the technical clarification meeting in March 1997, AMEC commenced the detailed design phase towards the end of April 1997, which was scheduled for completion by 29<sup>th</sup> December 1997. During the period of May to August 1997, AMEC developed the initial DST system design on which they conducted most of the safety studies. However, as discussed above, the HAZOP team identified problems with the use of the Bulk Storage Tanks located beneath the accommodation block. The internal AMEC response to the HAZOP questions about possible design options noted, on 30<sup>th</sup> August 1997, that the Base Oil Tanks were '*declared acceptable*' for use as DSTs<sup>9</sup>.

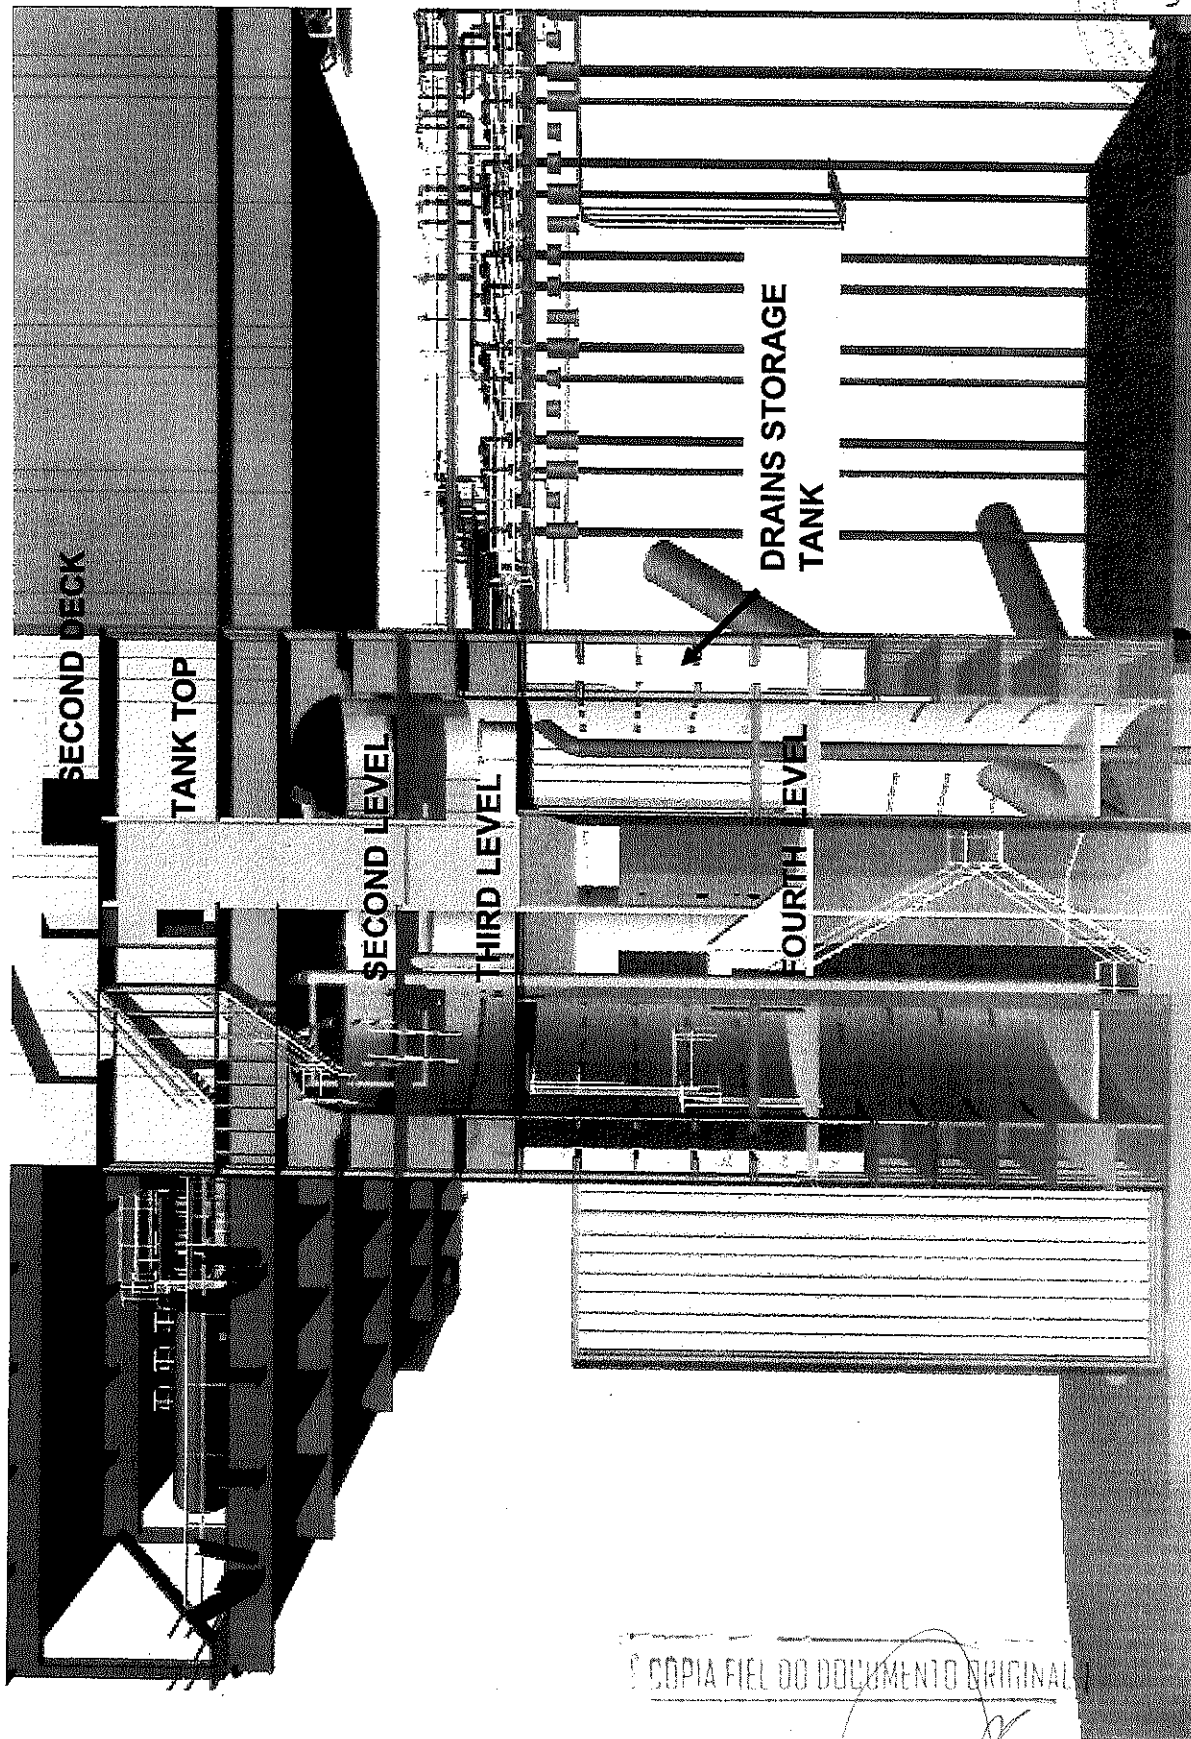
**FIGURE 13 – Cross-section of the Starboard Aft Column**

3.1.1 For the upgrade project, the ventilation system within the column remained unchanged from the original Fincantieri design, although the intake and exhaust ducting were raised to reduce the risk of downflooding. The air was supplied at the height of the Second Deck, through ducting to each level of the column and pontoon, with watertight dampers being installed at each watertight boundary. The exhaust ventilation was taken from the pontoon using the Access Shaft before being routed via ducting through Levels 3 & 2 to the exhaust outlet on the Second Deck Level. (A sketch of the ventilation system is given in Figure 20). A cross-section of the aft starboard column is shown in Figure 13.

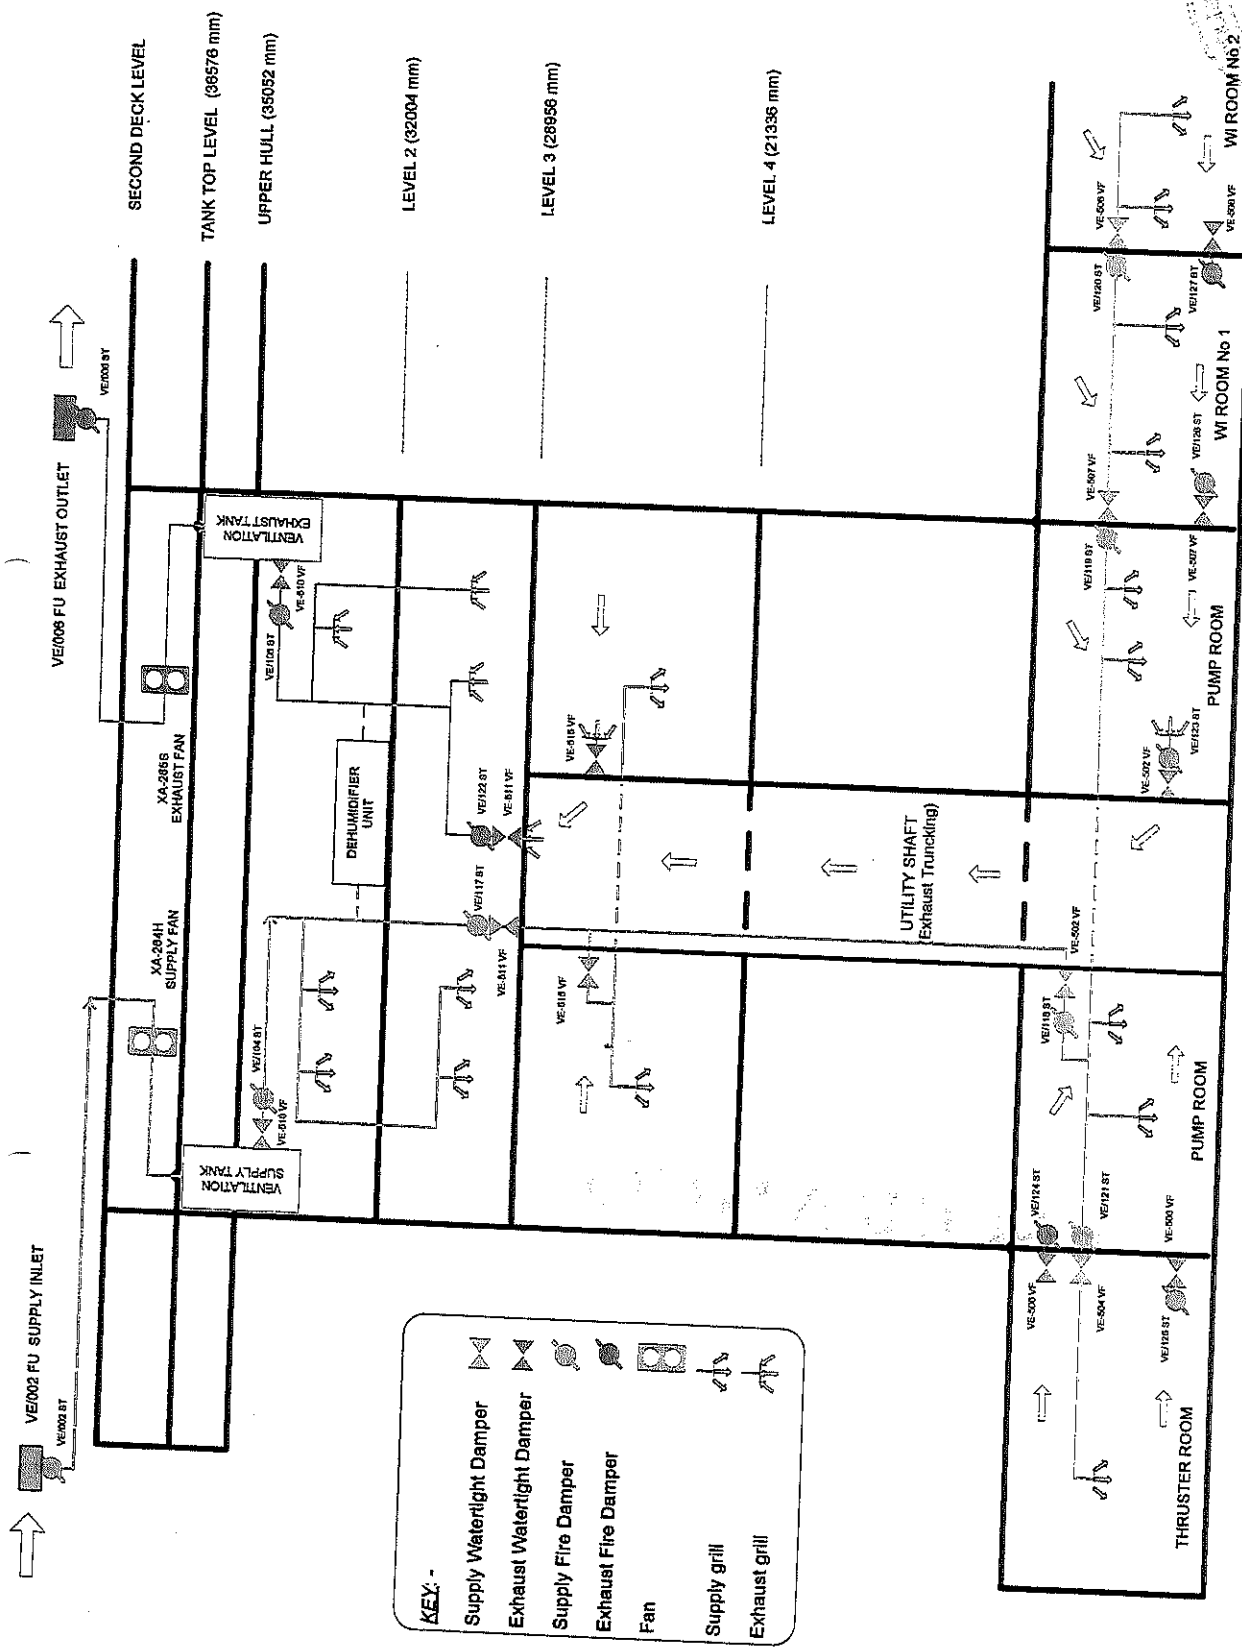
**FIGURE 20 – Sketch of Ventilation System in Aft Starboard Column**

- 3.3.17 The ventilation system provided by Fincantieri gave about 15 air changes per hour. There were no changes made to the internal column ventilation system during the upgrade project (see Figure 20). The Level 4 supply and exhausts were not designed specifically to provide 'dilution ventilation air'. Further, AMEC's internal review of the HVAC systems was based on the Hazardous Classification Drawings which did not refer to the conversion of the Base Oil Tanks into the DSTs<sup>34</sup>.
